From the Lab to the Field: Decoding Degradation at Cell, Module, and Field Level for SHJ and TOPCon

SPREE Seminar, 4 April 2025, Sydney, Australia

Bram Hoex, Chandany Sen, Muhammad Umair Khan, Xinyuan Wu, Xutao Wang, Haoran Wang, Jiexi Fu, Shukla Poddar, Phillip Hamer

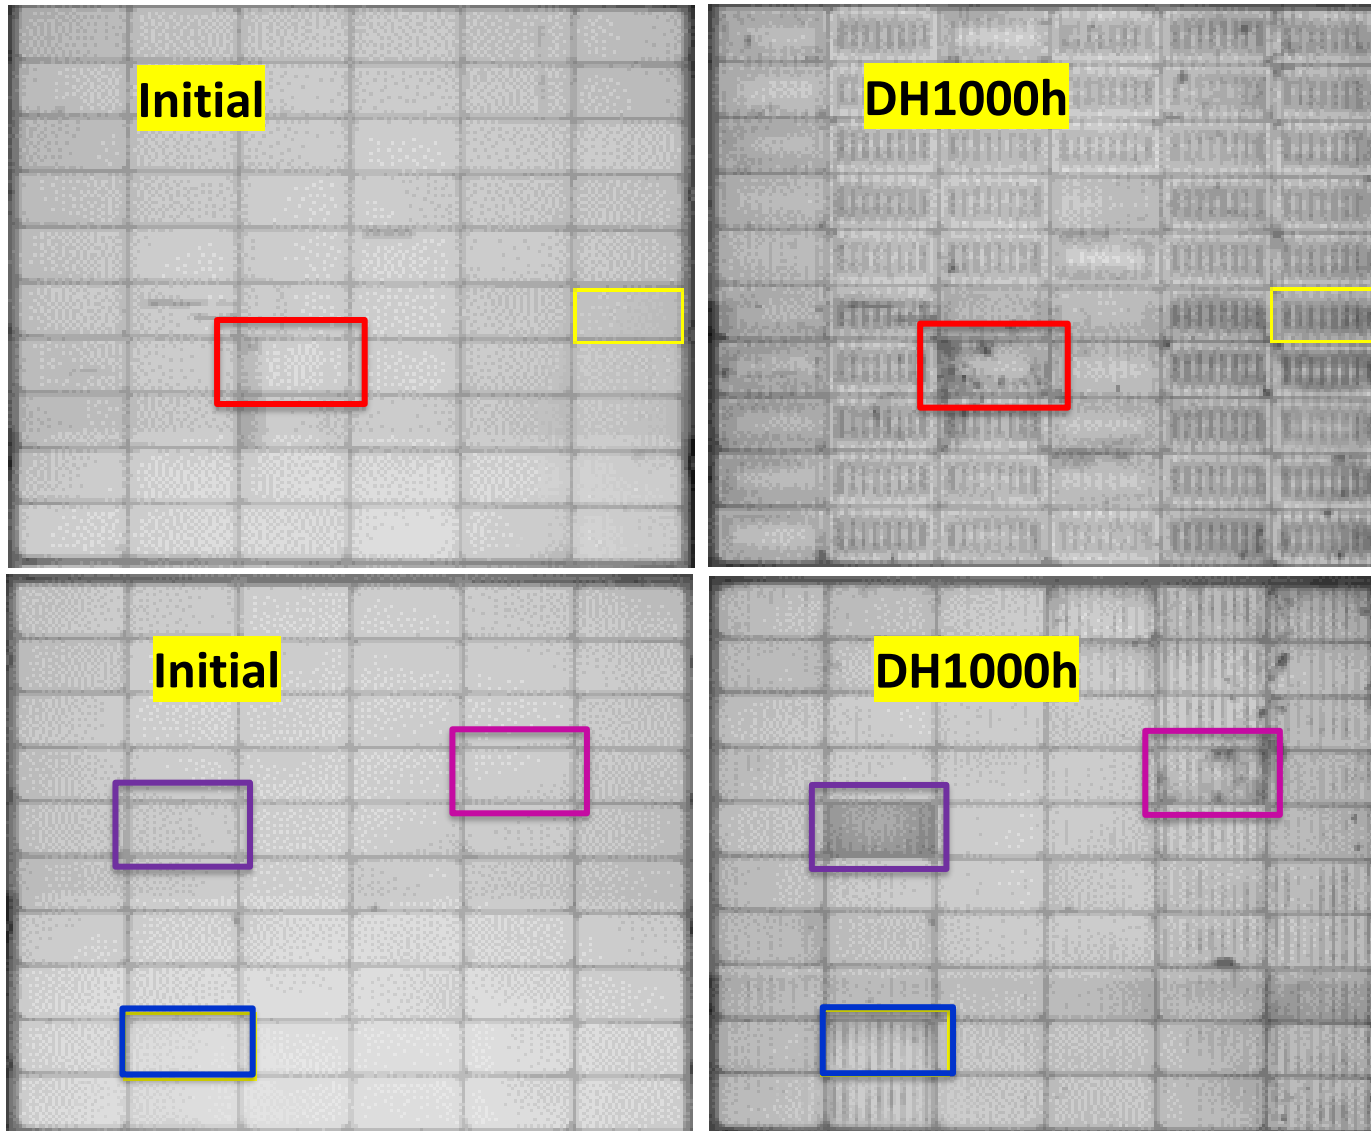
EL images of HJT full modules before and after 1000 h of DH testing

- Several failure modes in the HJT glass-backsheet full modules were detected with losses up to 22.5%_{rel}
- The root causes of each failure mode were unclear
- These failure modes occurred randomly in the full-modules
- Some of these failure modes were not observed in PERC modules previously
- Limited/no reports on failure modes in HJT glass-backsheet modules
- Cell-level testing developed for PERC cells (IEC 61215-2:2016) is unable to detect these failure modes

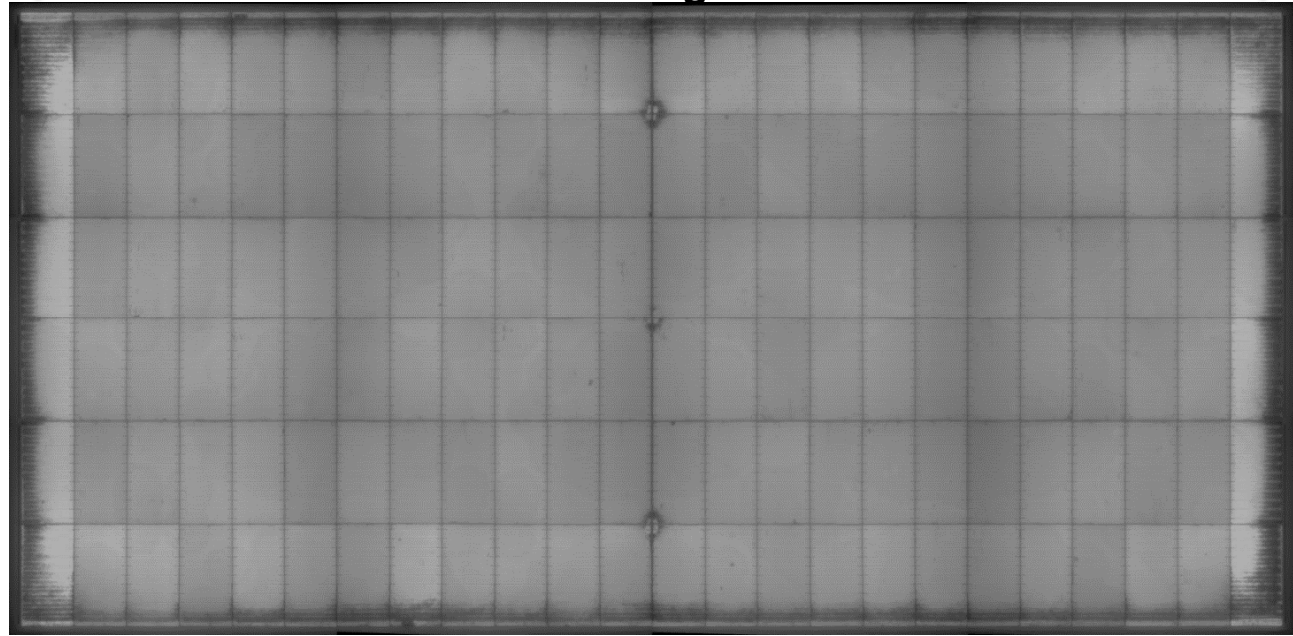
G/G: EVA/**EVA** post DH3000 **Loss: 8.28%_{rel}**

→ Speculated root cause of failure: corrosion of front metallization due to a chemical reaction involving **moisture and acetic acid (EVA, EPE) with the front metallization.**

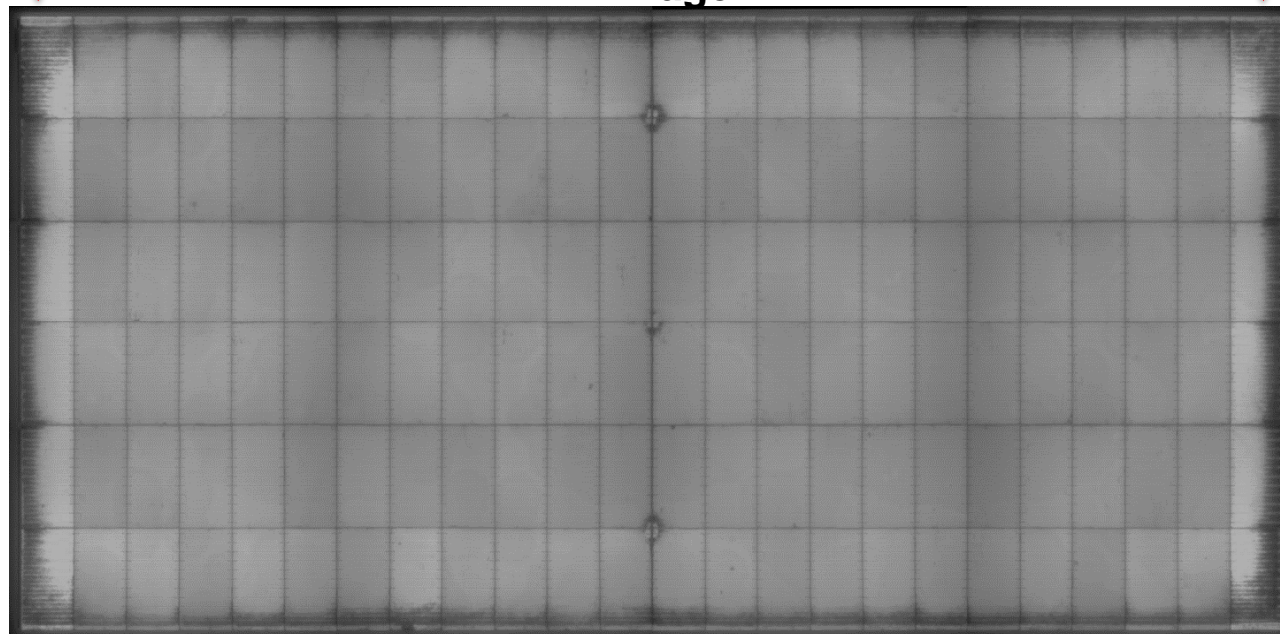
G/G: EVA/**EVA** post DH3000 **Loss: 8.28%_{rel}**

G/G: **EPE**/EVA post DH3000 **Loss (2.8%_{rel})**

→ Speculated root cause of failure: corrosion of front metallization due to a chemical reaction involving **moisture and acetic acid (EVA, EPE) with the front metallization.**

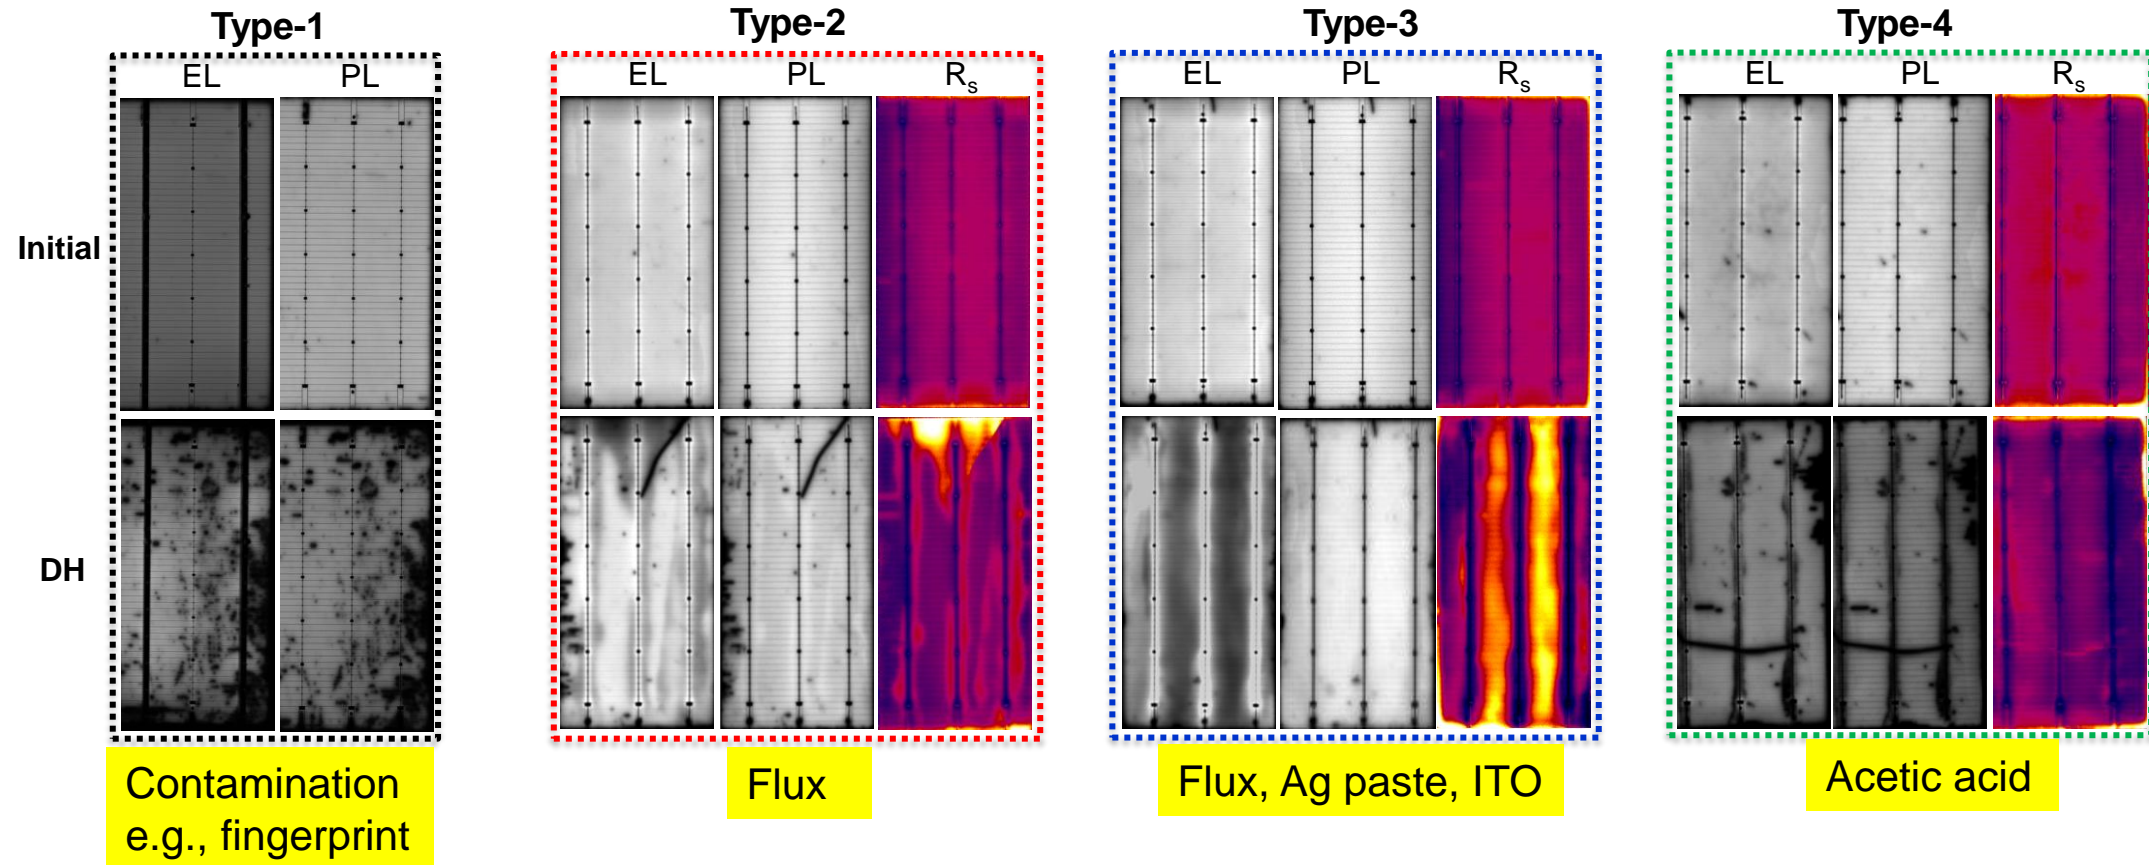
Type-1, 2, 3, and 4 failure modes reproduced in non-encapsulated cells

- All four failure modes can be reproduced in the non-encapsulated cells
- Root causes responsible for each failure mode have been identified
- Cell-level testing is one order of magnitude quicker than module-level testing

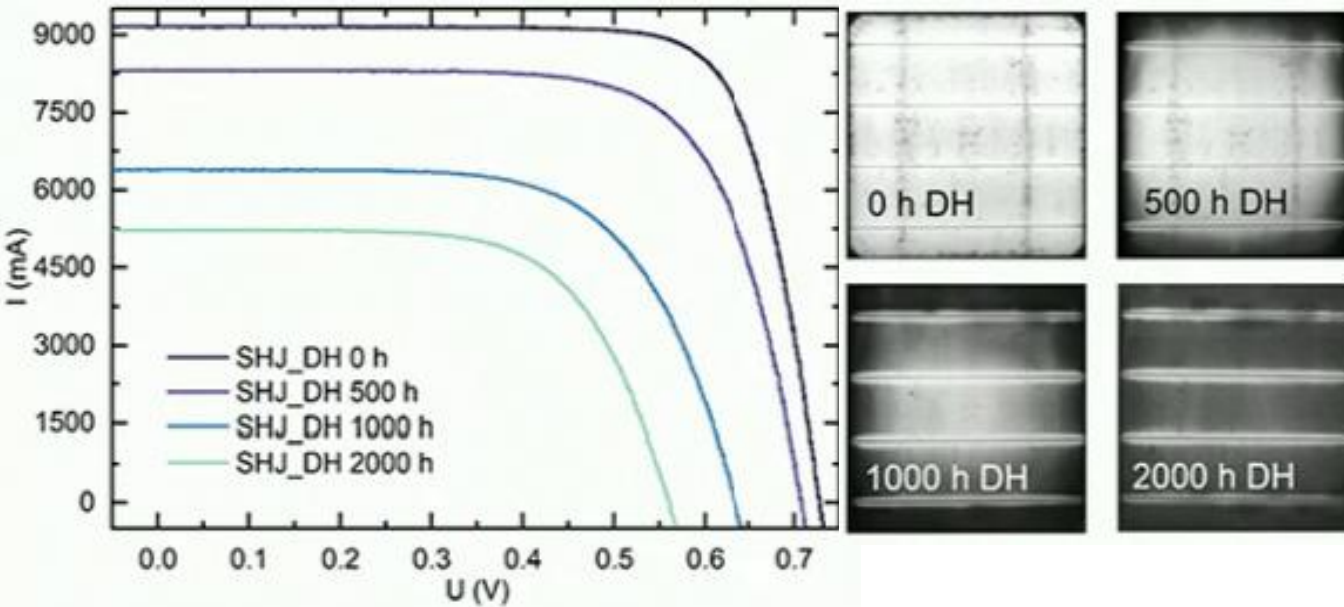
Glass/EVA/Glass HJT

→ Both HJT and TOPCon modules with Glass/EVA/Glass structure severely failed after DH testing

- In the case of HTJ modules, it was speculated that Na^+ might play a role in causing failure
- In the case of TOPCon modules, it was speculated that acetic acid may play a role

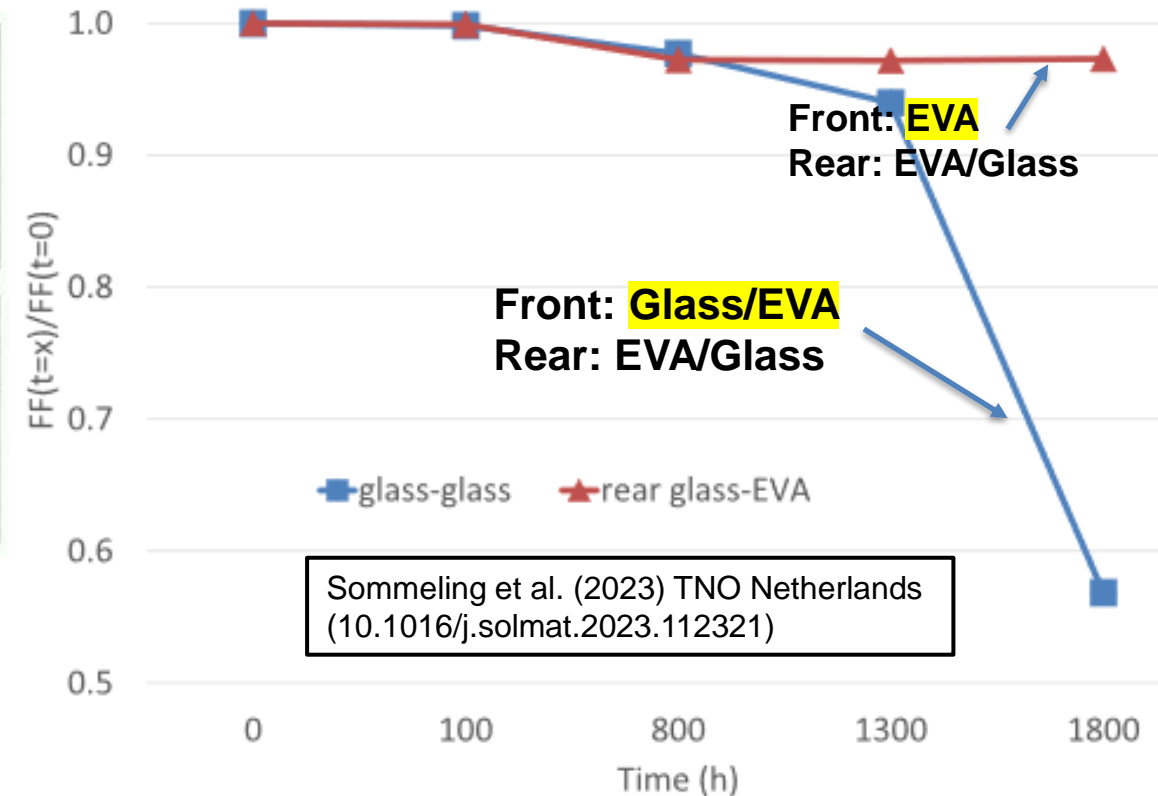
Glass/EVA/Glass TOPCon

→ **However, it is highly likely that Na^+ might be involved in the degradation of both HJT and TOPCon modules**

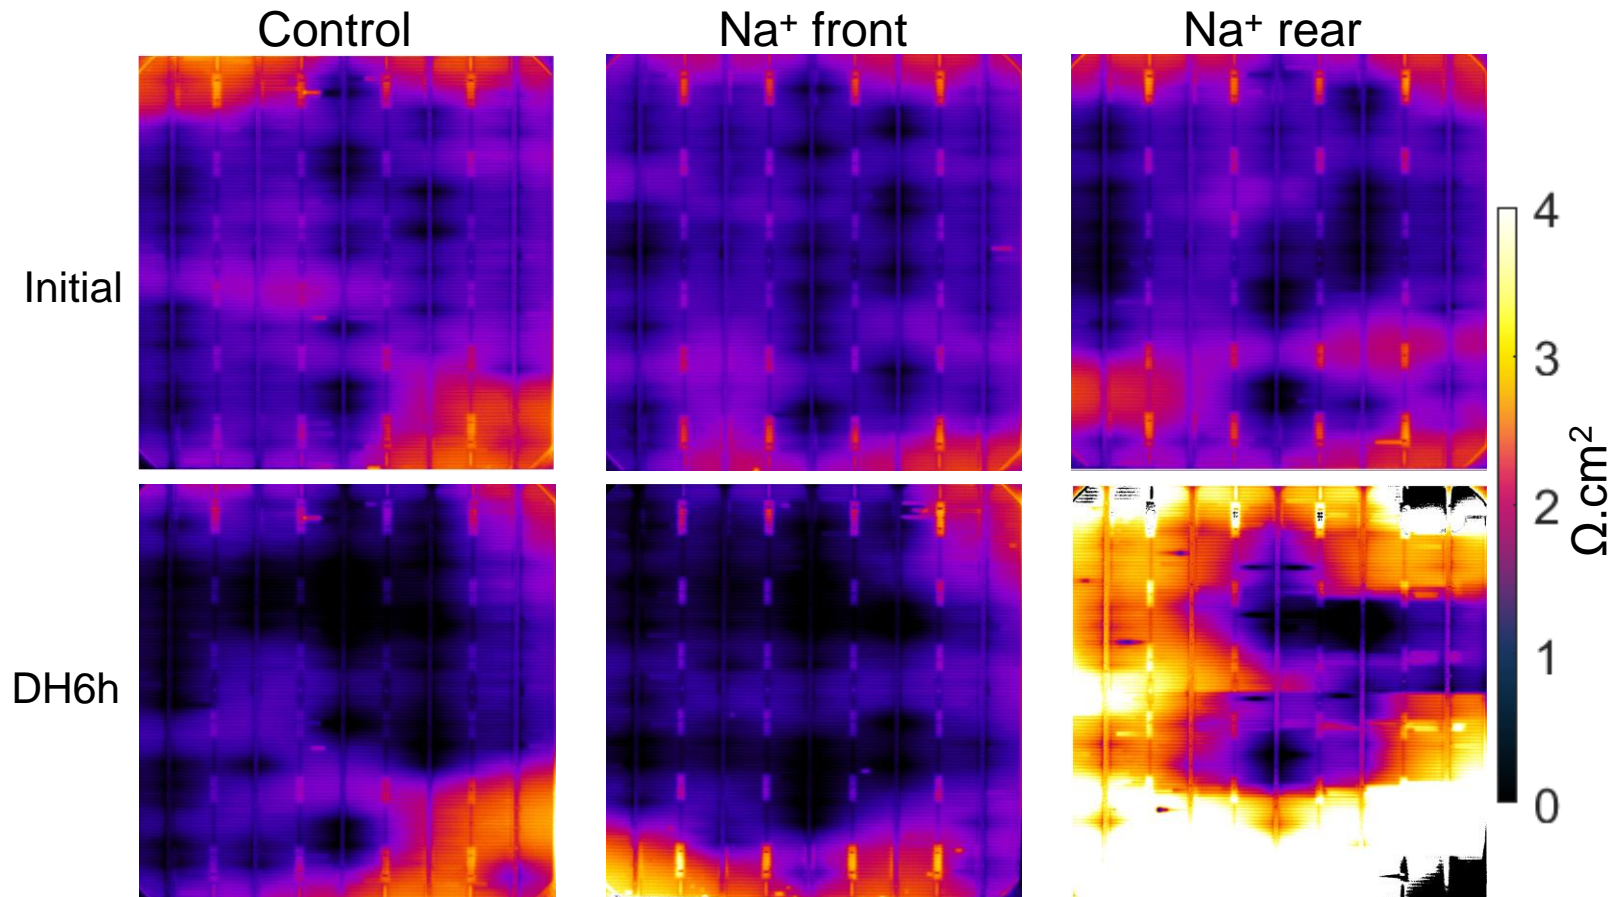
Change in R_s images after damp heat testing of PERC cells

- No R_s change was observed on the control cell, and the cell with Na^+ was exposed only on the front side after damp heat (DH) testing.
- R_s of cells with Na^+ pre-exposed to the rear side substantially increased after DH testing.

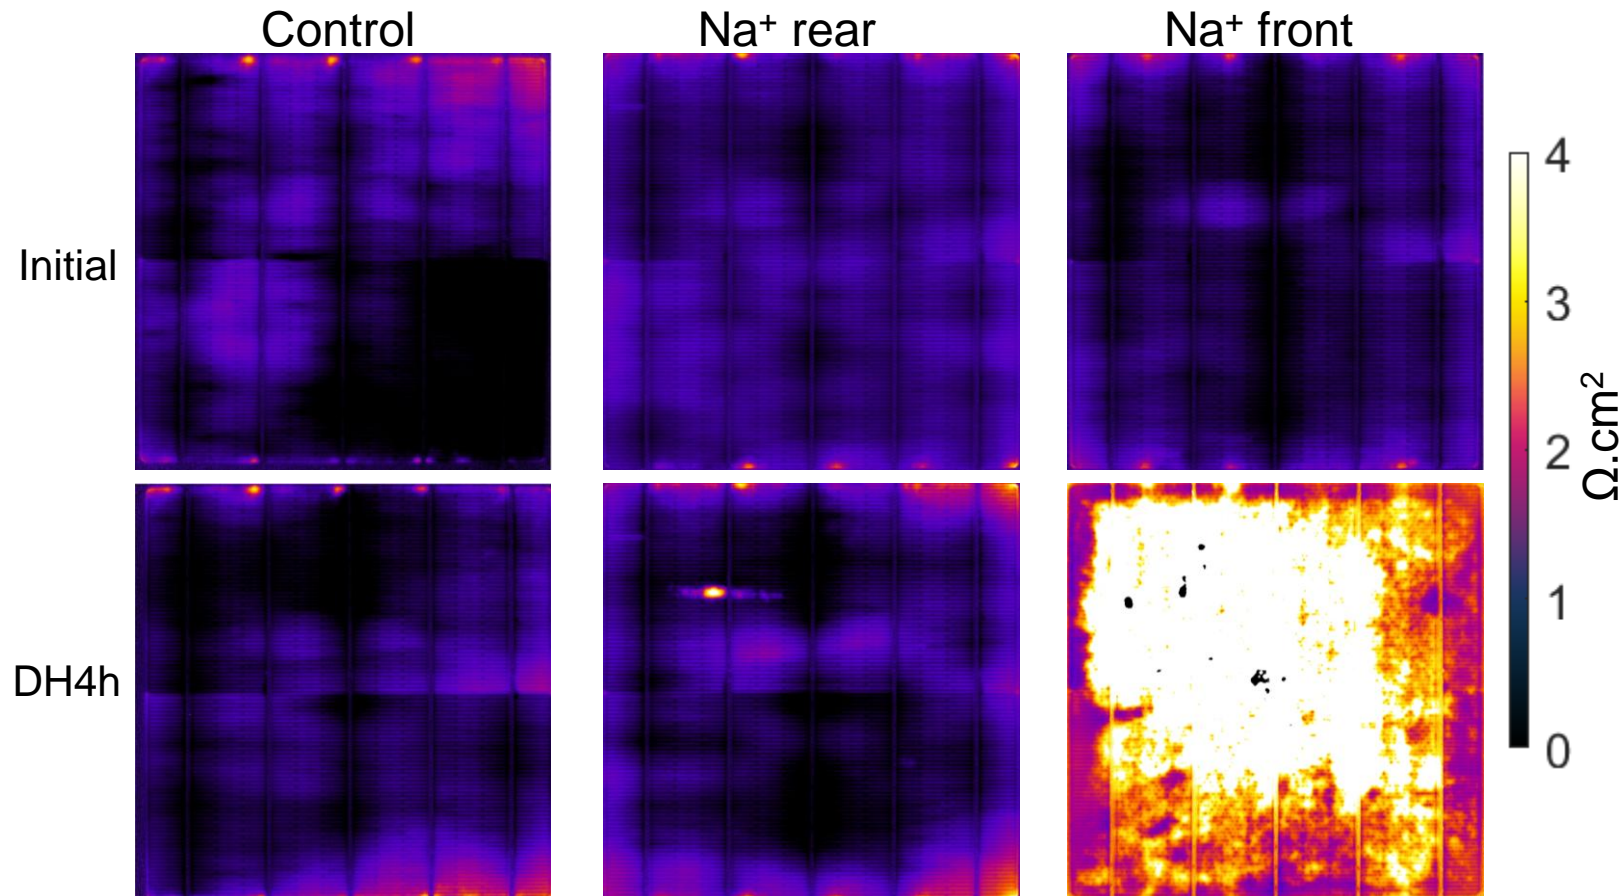
Change in R_s images after damp heat testing of TOPCon cells

- No R_s change was observed on the control cell, and the cell with Na^+ was exposed only on the rear side after damp heat (DH) testing.
- R_s of cells with Na^+ pre-exposed to the front side substantially increased after DH testing.

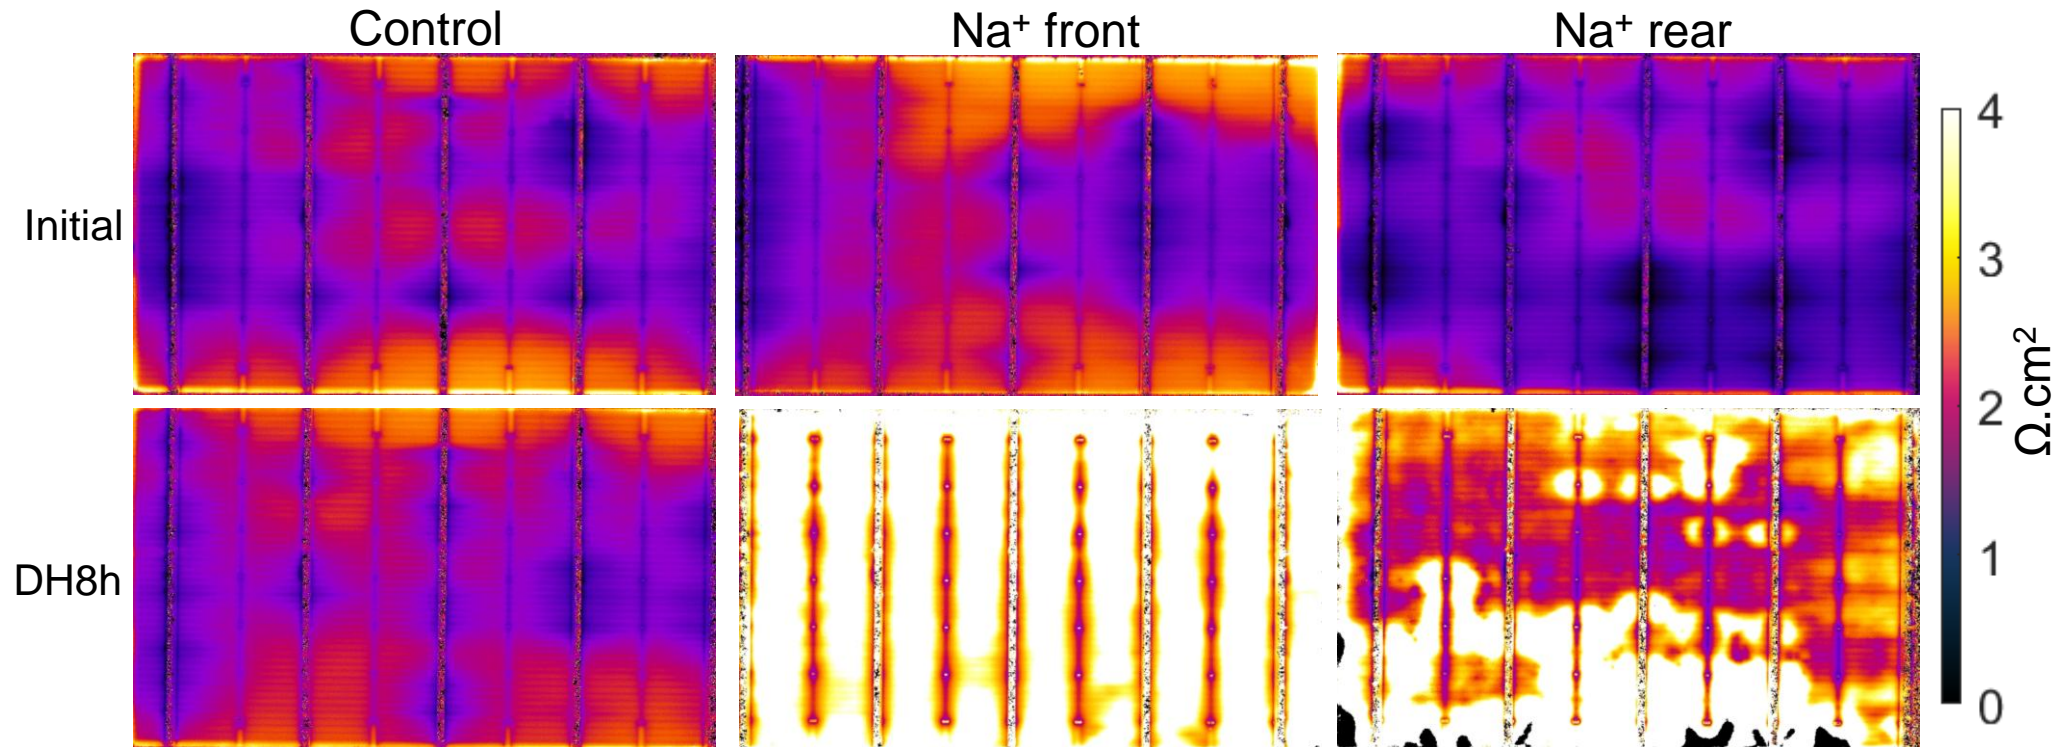
Change in R_s images after damp heat testing of HJT cells

- No R_s change was observed on the control cell.
- R_s of cells with Na^+ pre-exposed to the front or rear side substantially increased after DH testing.

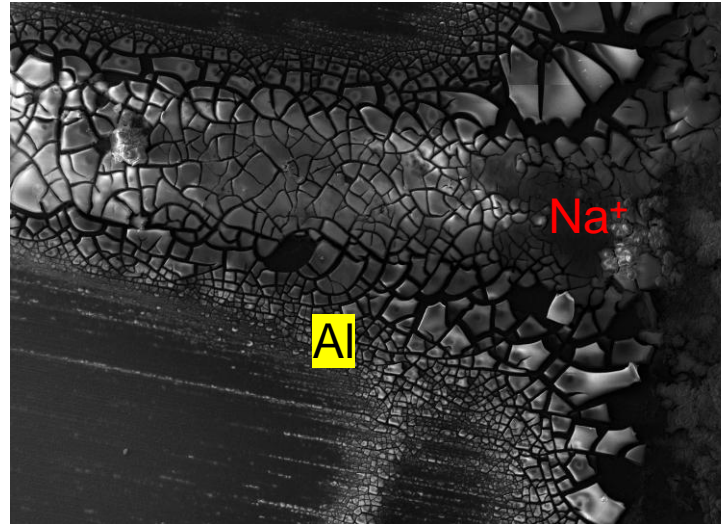
Completely damaged

→ Chemically reaction between Al contact, Na⁺ and moisture, leading to corrosion of the contact electrode

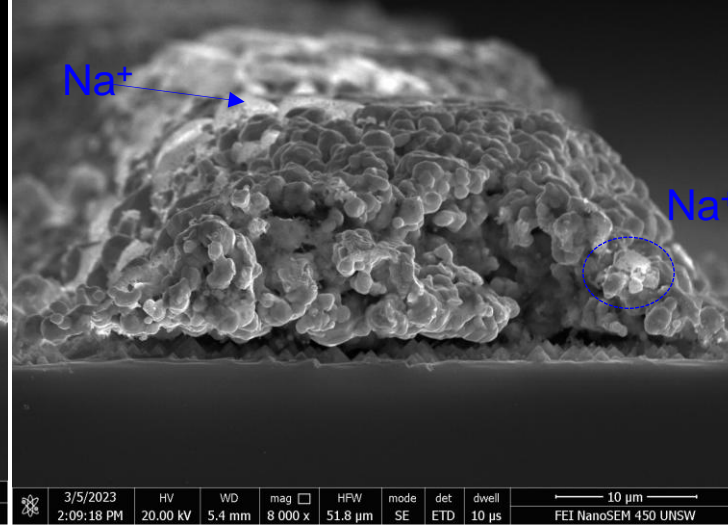
→ Chemical reaction between Na⁺, moisture, Ag, and binder resin

→ Degradation of binder resin

→ Delamination of finger electrode and change in particle size (small to big) for both front and rear contacts

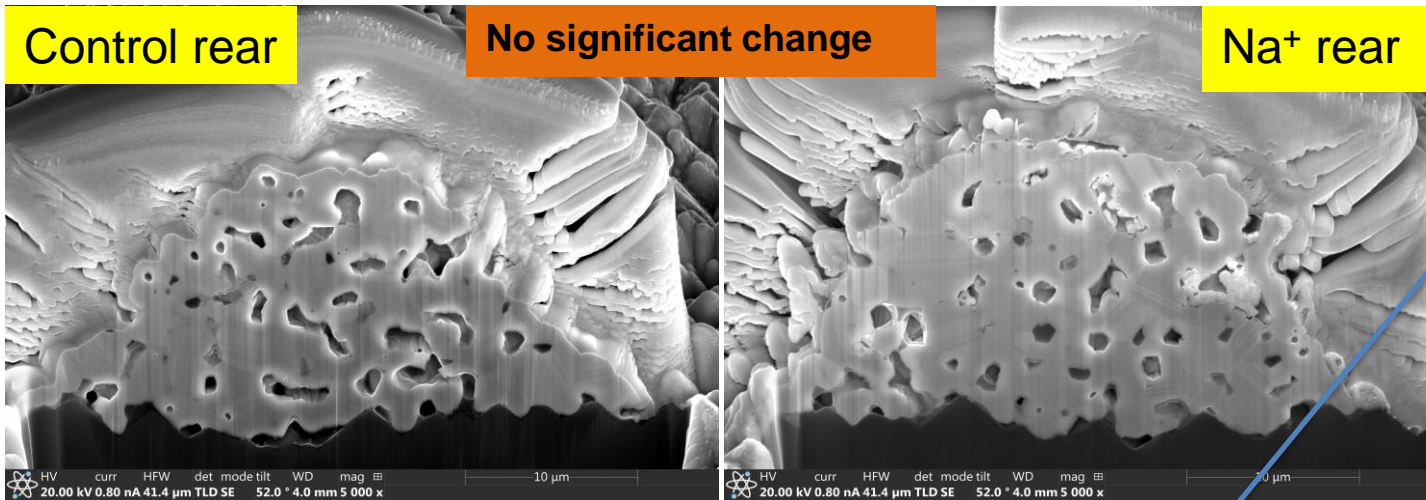
TOPCon contact: SEM-cross section images

- Chemical reaction between Na⁺, moisture, Al, and glass frit layer (PbO)
- degradation of the glass layer (PbO), increased porosity, and delaminate of finger electrode (weak adhesive)

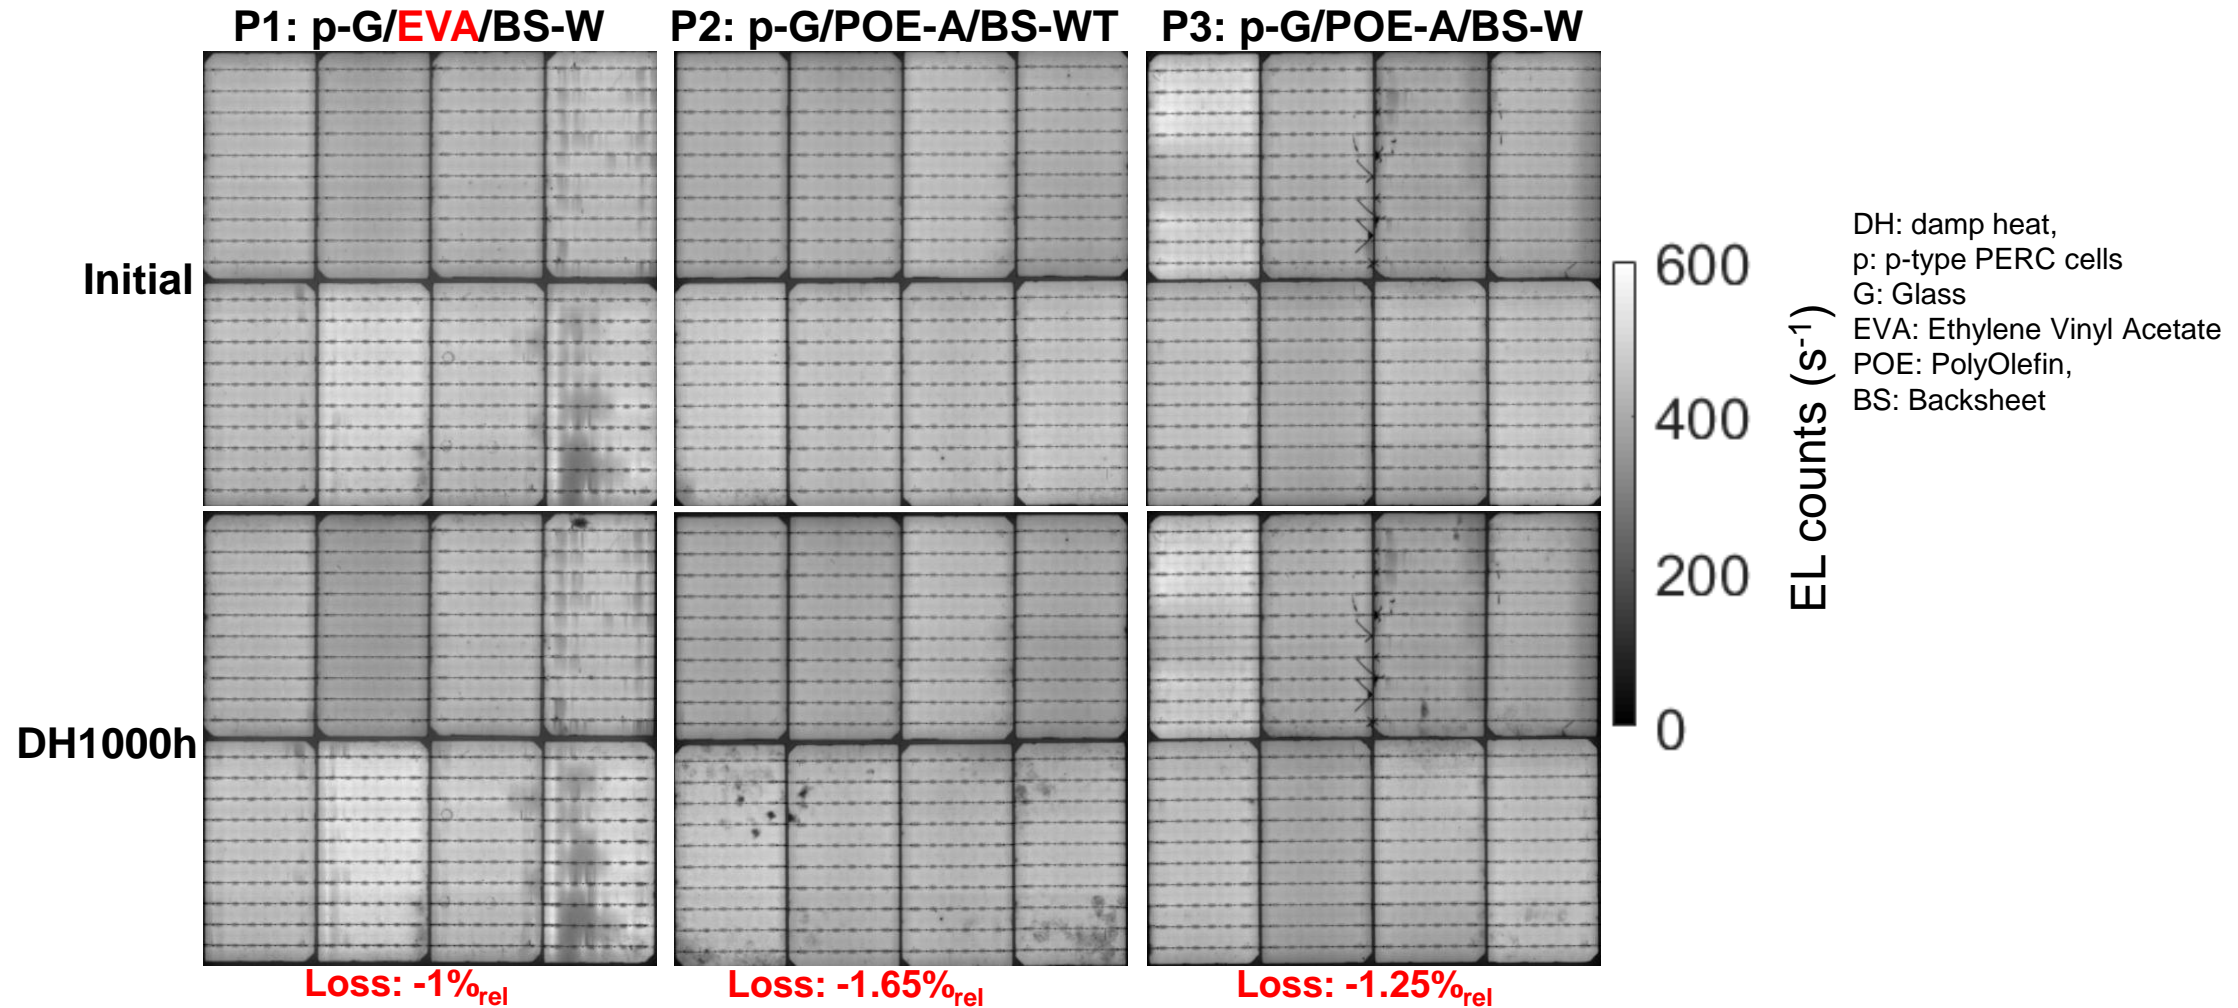
Changes in EL images of modules with PERC cells

- No significant changes after 1000 hrs of DH testing.
- Changing bill of material (BOM) does not seem to significantly impact loss.

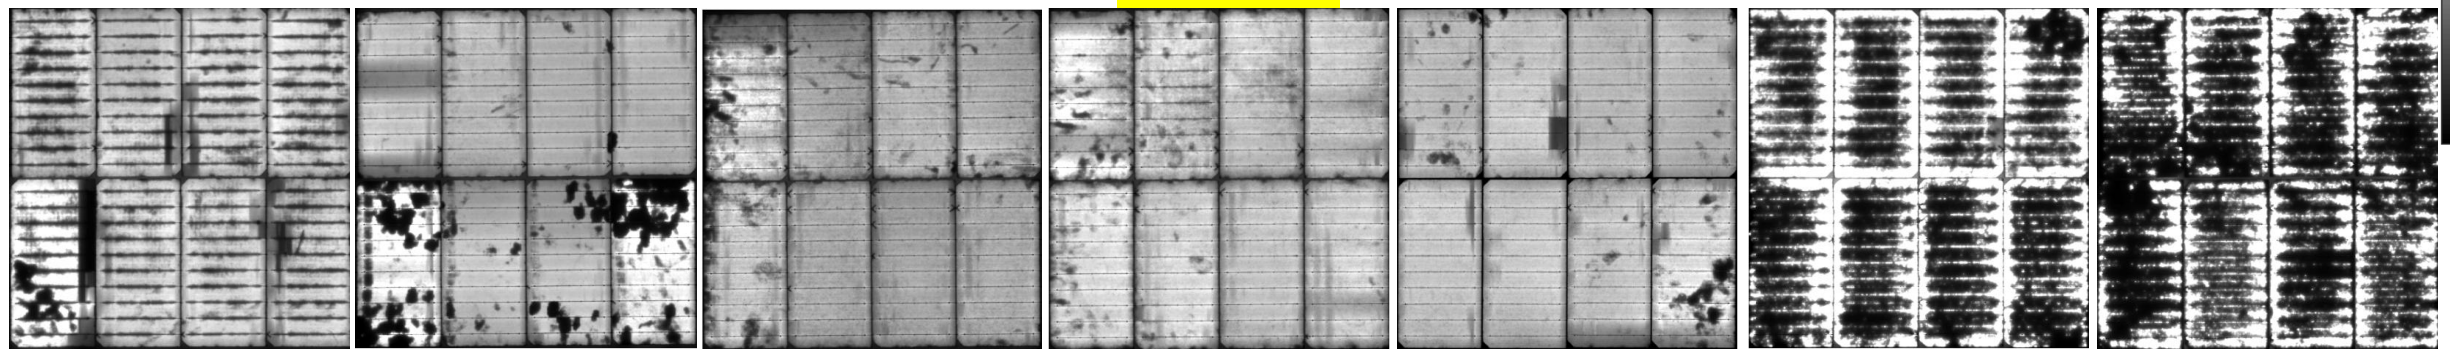
Changes in EL images of modules with **TOPCon cells** after DH1000hrs

Loss: -11%_{rel} **Loss: -16%_{rel}** **Loss: -5.4%_{rel}** **Loss: -6%_{rel}** **Loss: -3.4%_{rel}** **Loss: -53.5%_{rel}** **Loss: -65.1%_{rel}**

- Degradation extent is beyond the minimum loss specified in the IEC standard ($\leq 2\%$ relative after DH2000hrs).
- Failure modes are random
- Modules with EVA degrade less than some modules with POE-C, indicating failure isn't solely related to acetic acid.....

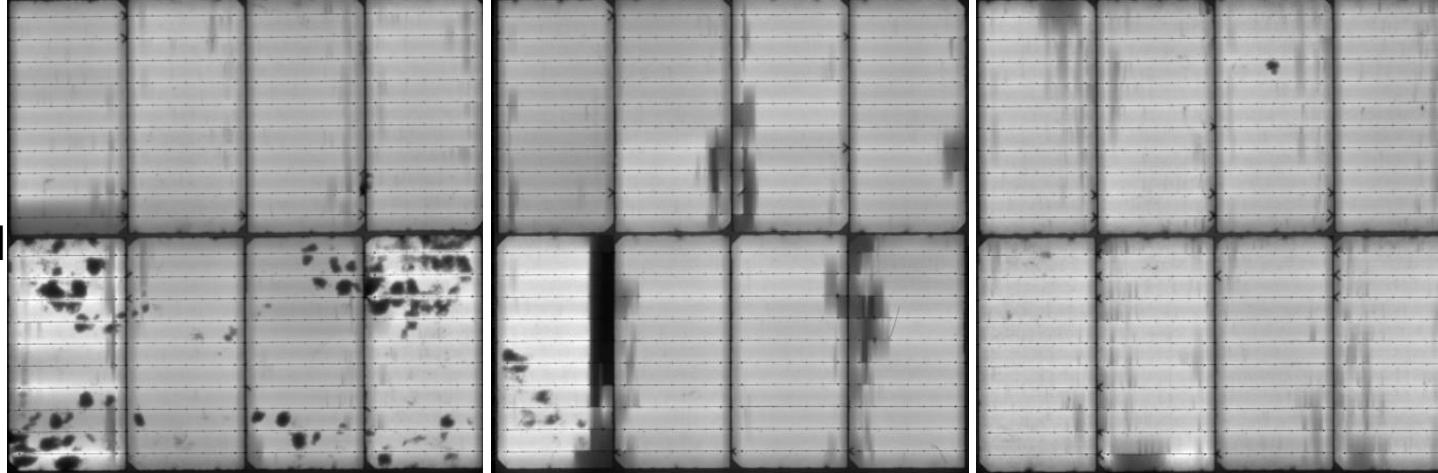
P_{\max} loss ~15%_{rel}

P_{\max} loss ~11%_{rel}

P_{\max} loss ~65%_{rel}

Type-1 failure mode: point-localized failure

Type-2 failure mode: failure at/around the interconnection point

Type-3 failure mode: failure across the entire area of cells/module

- Three failure modes has been realised in TOPCon modules, but absent in PERC modules
- These failure modes are quite similar to HJT modules

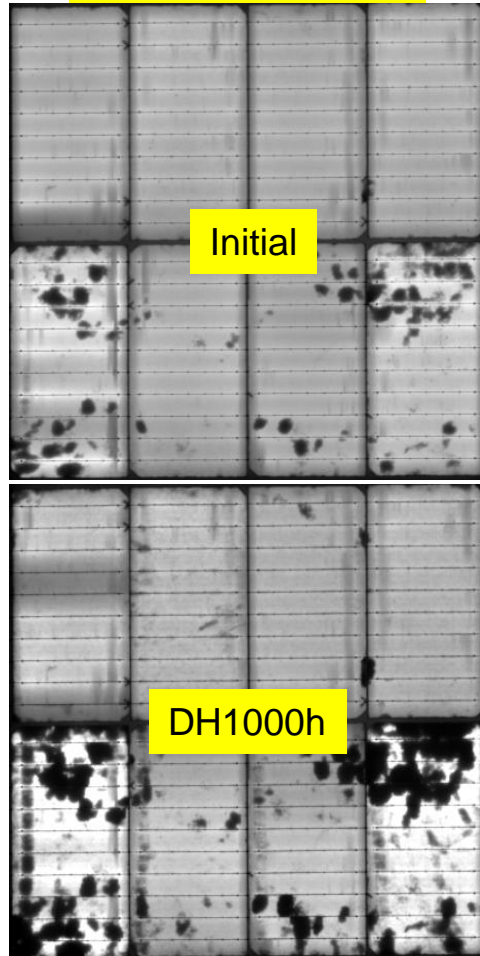
Type-1 failure mode
TOPCon modules

P_{\max} loss ~15%_{rel}
 I_{SC} loss ~0.8%_{rel}
 R_s increase ~55%_{rel}
Glass/**POE**/Backsheet

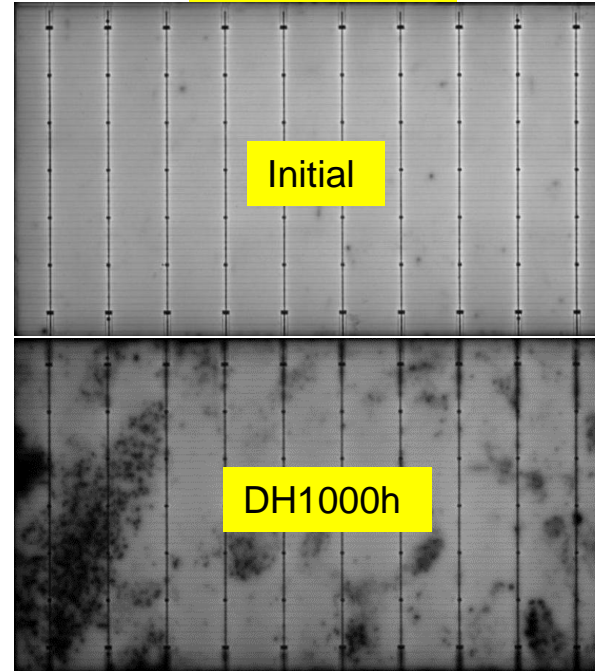
Type-1 failure mode
HJT modules

P_{\max} loss ~12%_{rel}
 V_{OC} loss ~2%_{rel}
 I_{SC} loss ~3%_{rel}

Glass/**EVA**/Backsheet

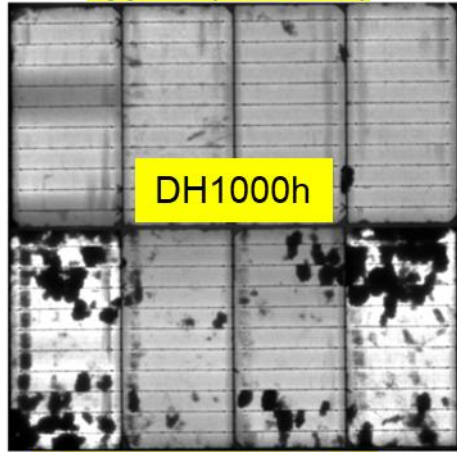
Type-1 (TOPCon)

Type-1 failure mode: potential root causes: Na, Cl and/or soldering flux

P_{max} loss ~15%_{rel}
 I_{sc} loss ~0.8%_{rel}
 R_s increase ~55%_{rel}

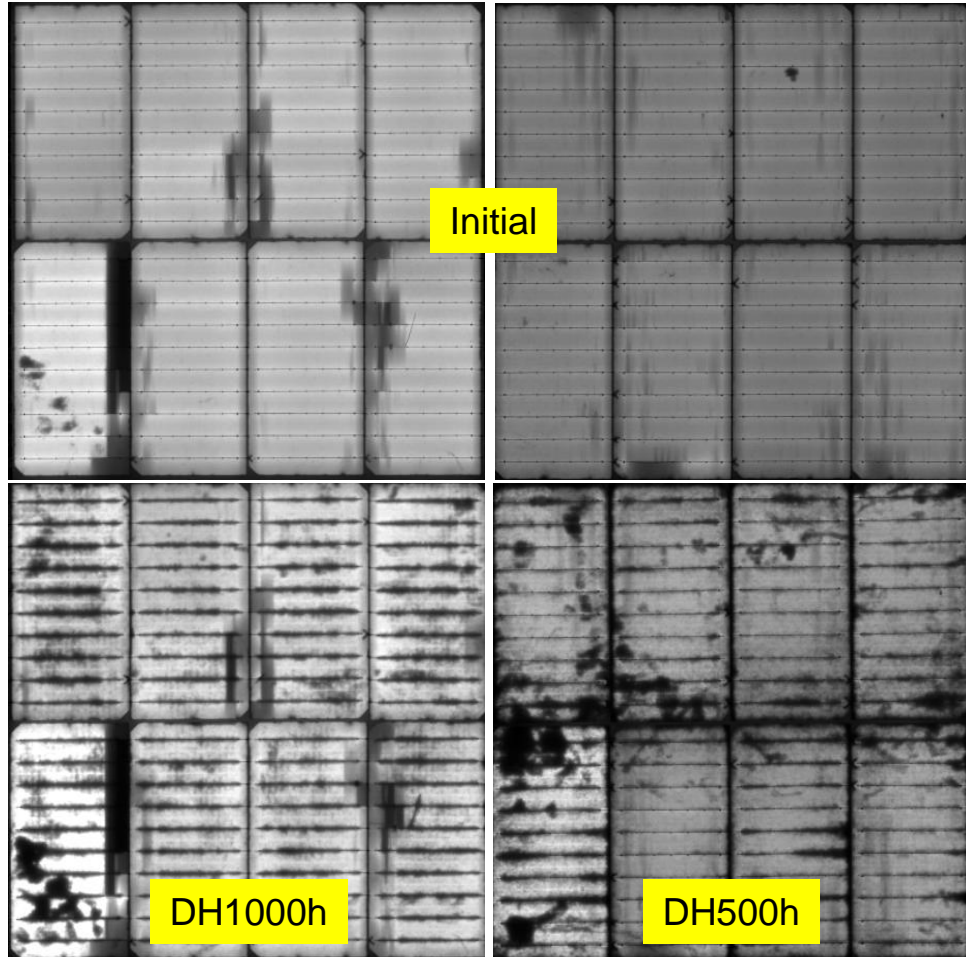
Type-2 failure mode
TOPCon modules

P_{\max} loss ~11%_{rel}

P_{\max} loss ~16%_{rel}

I_{SC} loss ~0.8%_{rel}

R_s increases ~50-55%_{rel}

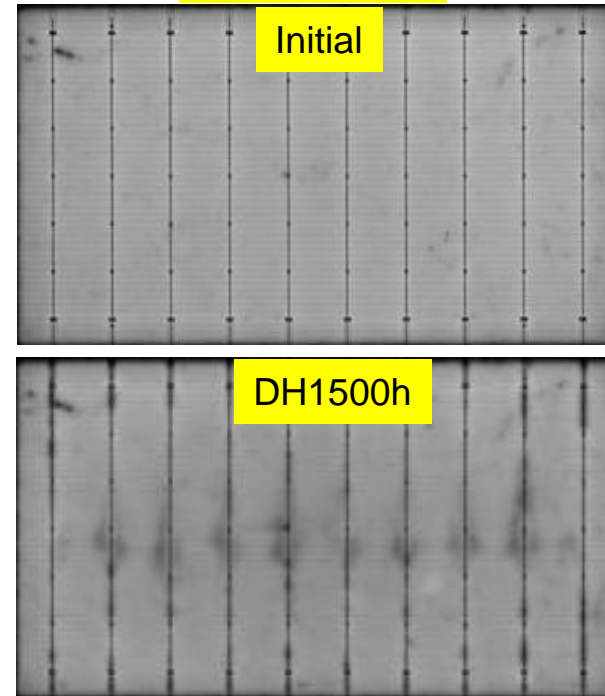
Type-2 failure mode
HJT modules

P_{\max} loss ~5%_{rel}

R_s increases ~33%_{rel}

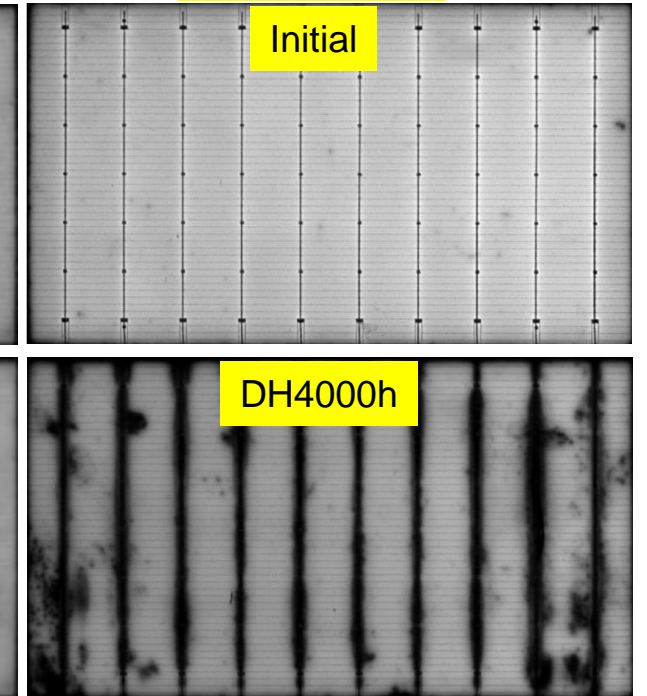
Type-4 failure mode
HJT modules

P_{\max} loss ~16%_{rel}

V_{OC} and I_{SC} loss ~3%_{rel}

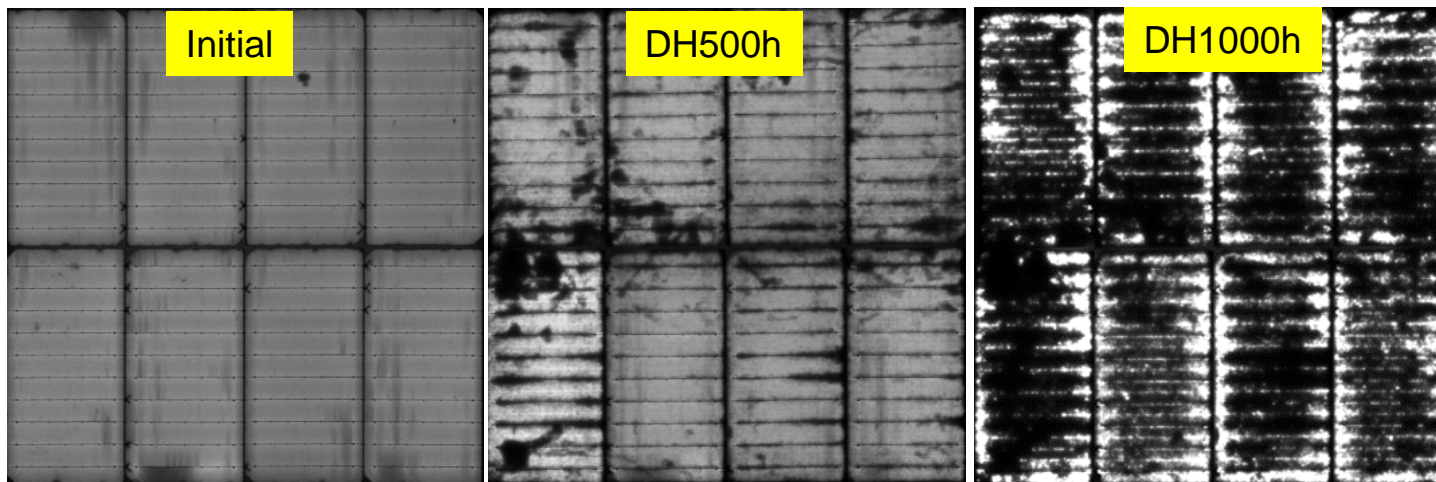
Type-3 failure mode (TOPCon modules)

Glass/**POE**/Backsheet

P_{\max} loss $\sim 65\%_{\text{rel}}$
 R_s increases $\sim 640\%_{\text{rel}}$

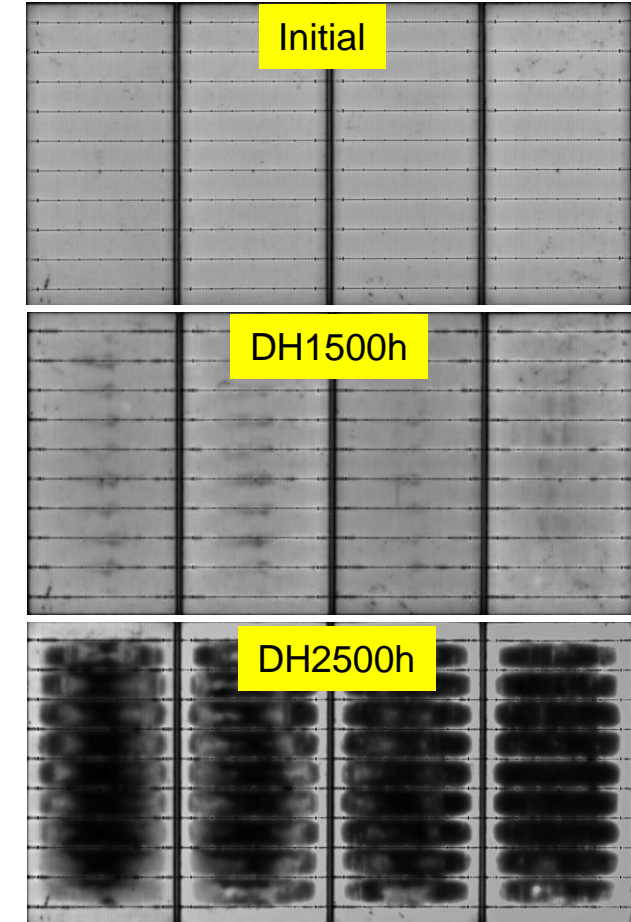
Type-3 failure mode (HJT modules)

P_{\max} loss $\sim 50\%_{\text{rel}}$
 R_s increases $\sim 300\%_{\text{rel}}$

Glass/**EVA**/Backsheet

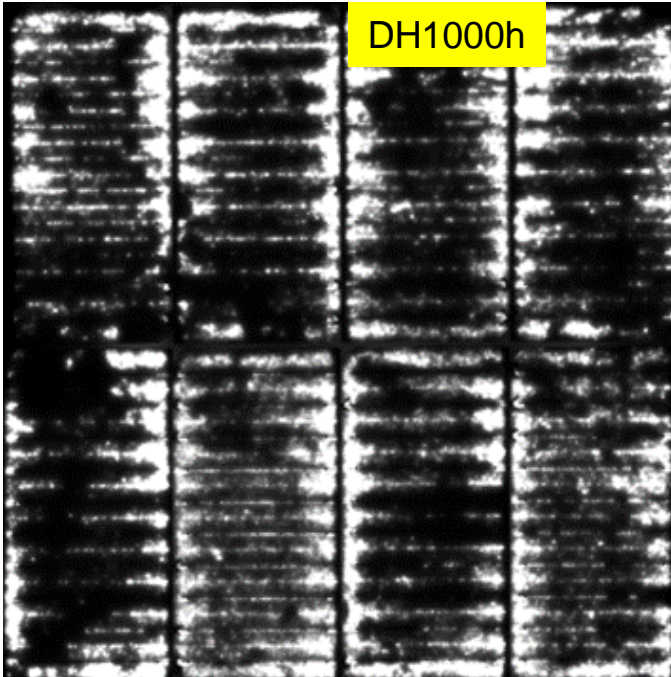
Type-3 failure mode
(TOPCon modules)

Type-3 failure mode in TOPCon: potential root causes: **Soldering flux and POE**

- Type-3 failure mode in TOPCon module with POE occurs more quickly than that of the HJT module with EVA.
 - Therefore, it is speculated that some **additive release from POE** is also involved in causing Type-3 failure mode in TOPCon modules.
