From the Lab to the Field: Decoding Degradation at Cell, Module, and Field Level for SHJ and TOPCon

SPREE Seminar, 4 April 2025, Sydney, Australia

Bram Hoex, Chandany Sen, Muhammad Umair Khan, Xinyuan Wu, Xutao Wang, Haoran Wang, Jiexi Fu, Shukla Poddar, Phillip Hamer

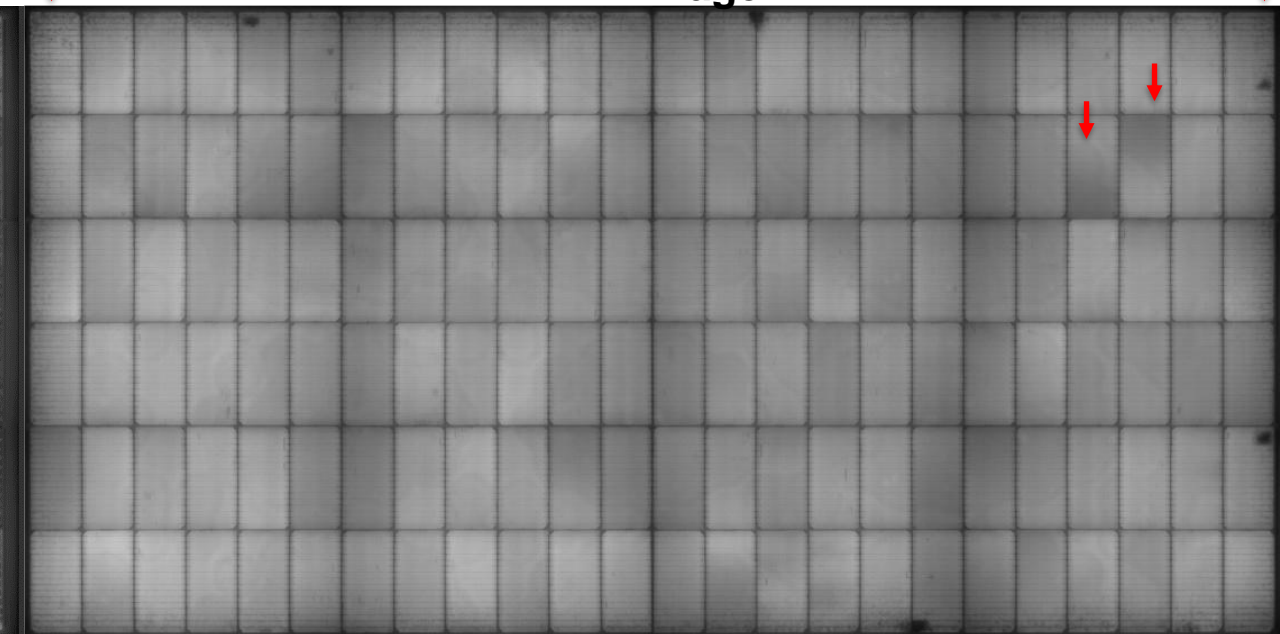
EL image

G/G: EVA/**EVA** post DH3000 **Loss: 8.28%_{rel}**

G/G: **EPE**/EVA post DH3000 **Loss (2.8%_{rel})**

→ Speculated root cause of failure: corrosion of front metallization due to a chemical reaction involving **moisture and acetic acid (EVA, EPE) with the front metallization.**

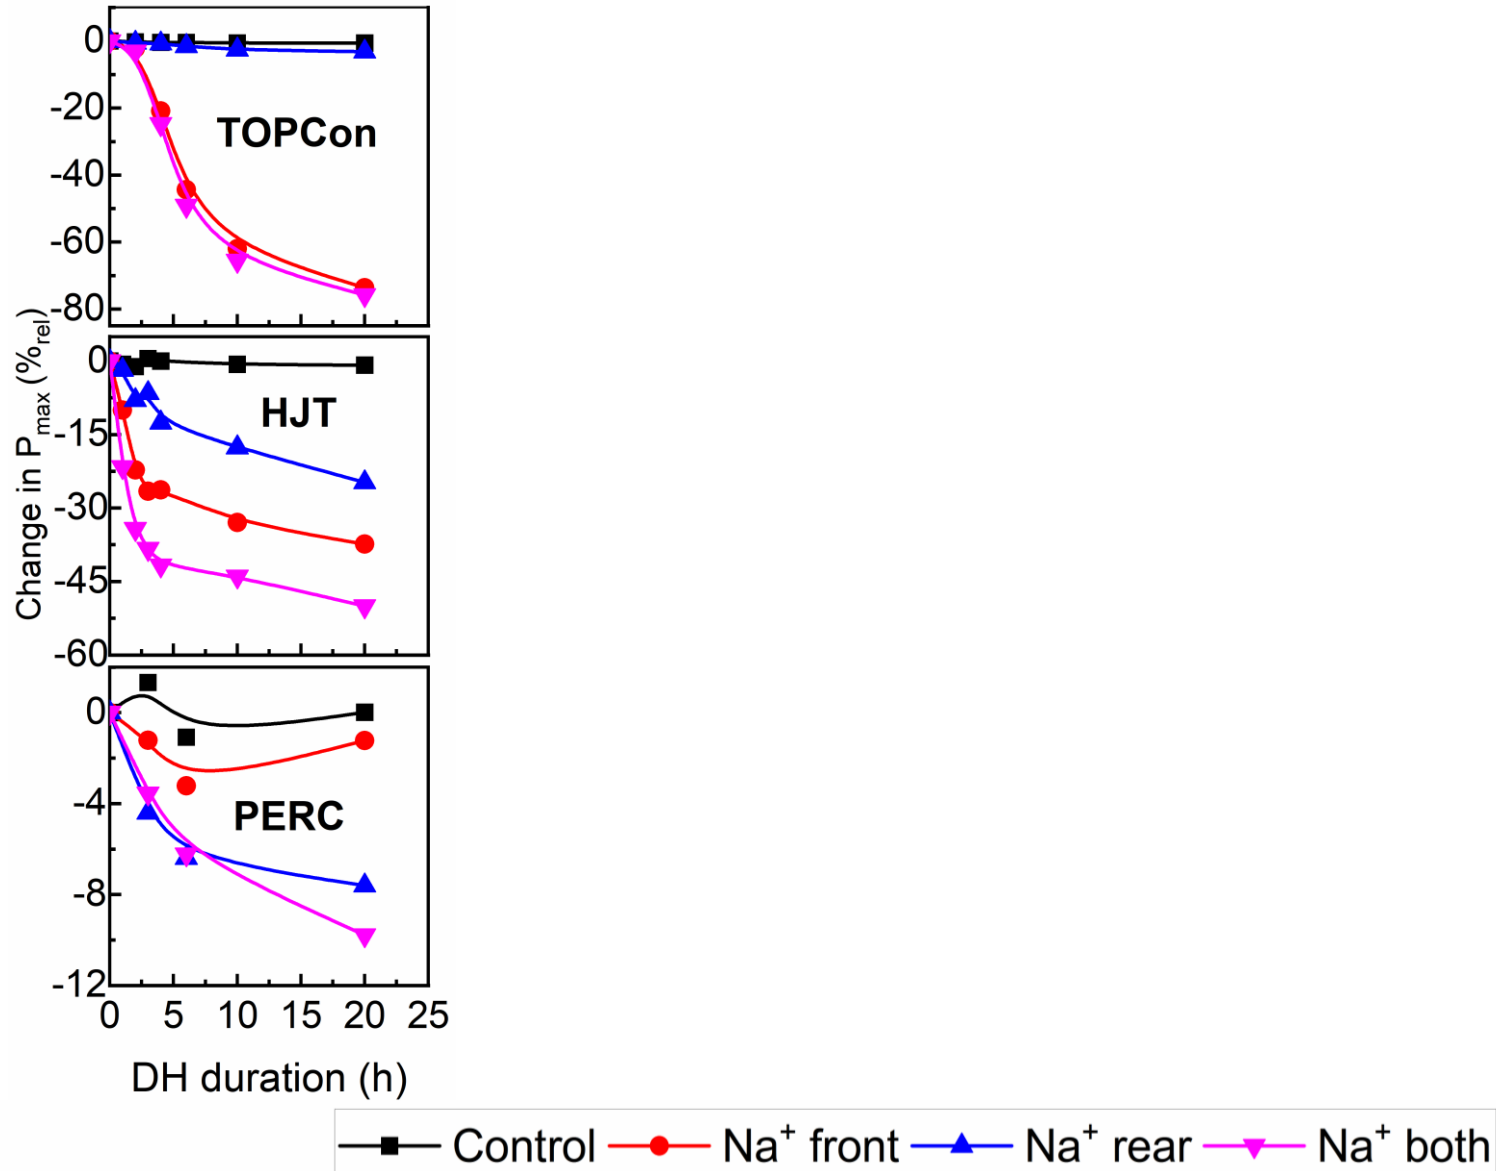
Change in I-V parameters after damp heat testing

- TOPCon cells degrade $\sim 75\%_{rel}$ (mainly on the front side).
- HJT cells degrade $\sim 50\%_{rel}$ (both sides).
- PERC cells degrade $\sim 10\%_{rel}$ (mainly on the rear side).

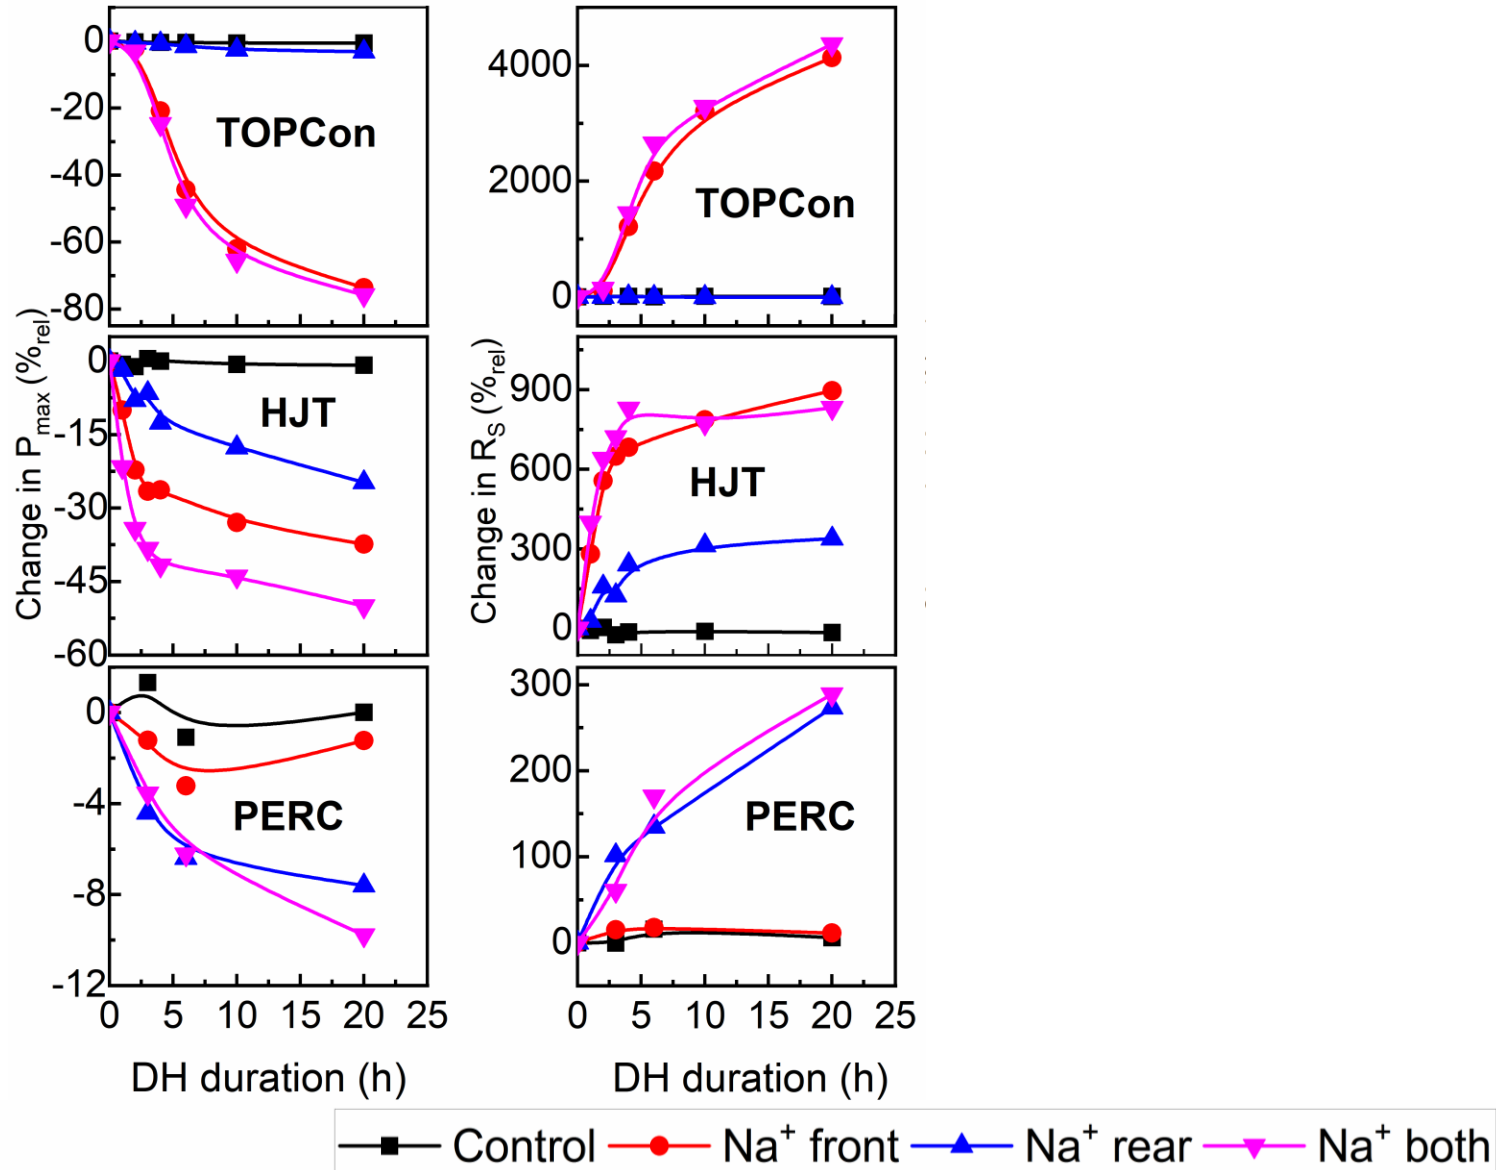
Change in I-V parameters after damp heat testing

- TOPCon cells degrade $\sim 75\%_{rel}$ (mainly on the front side).
- HJT cells degrade $\sim 50\%_{rel}$ (both sides).
- PERC cells degrade $\sim 10\%_{rel}$ (mainly on the rear side).
- Main loss is due to a severe increase in R_s .

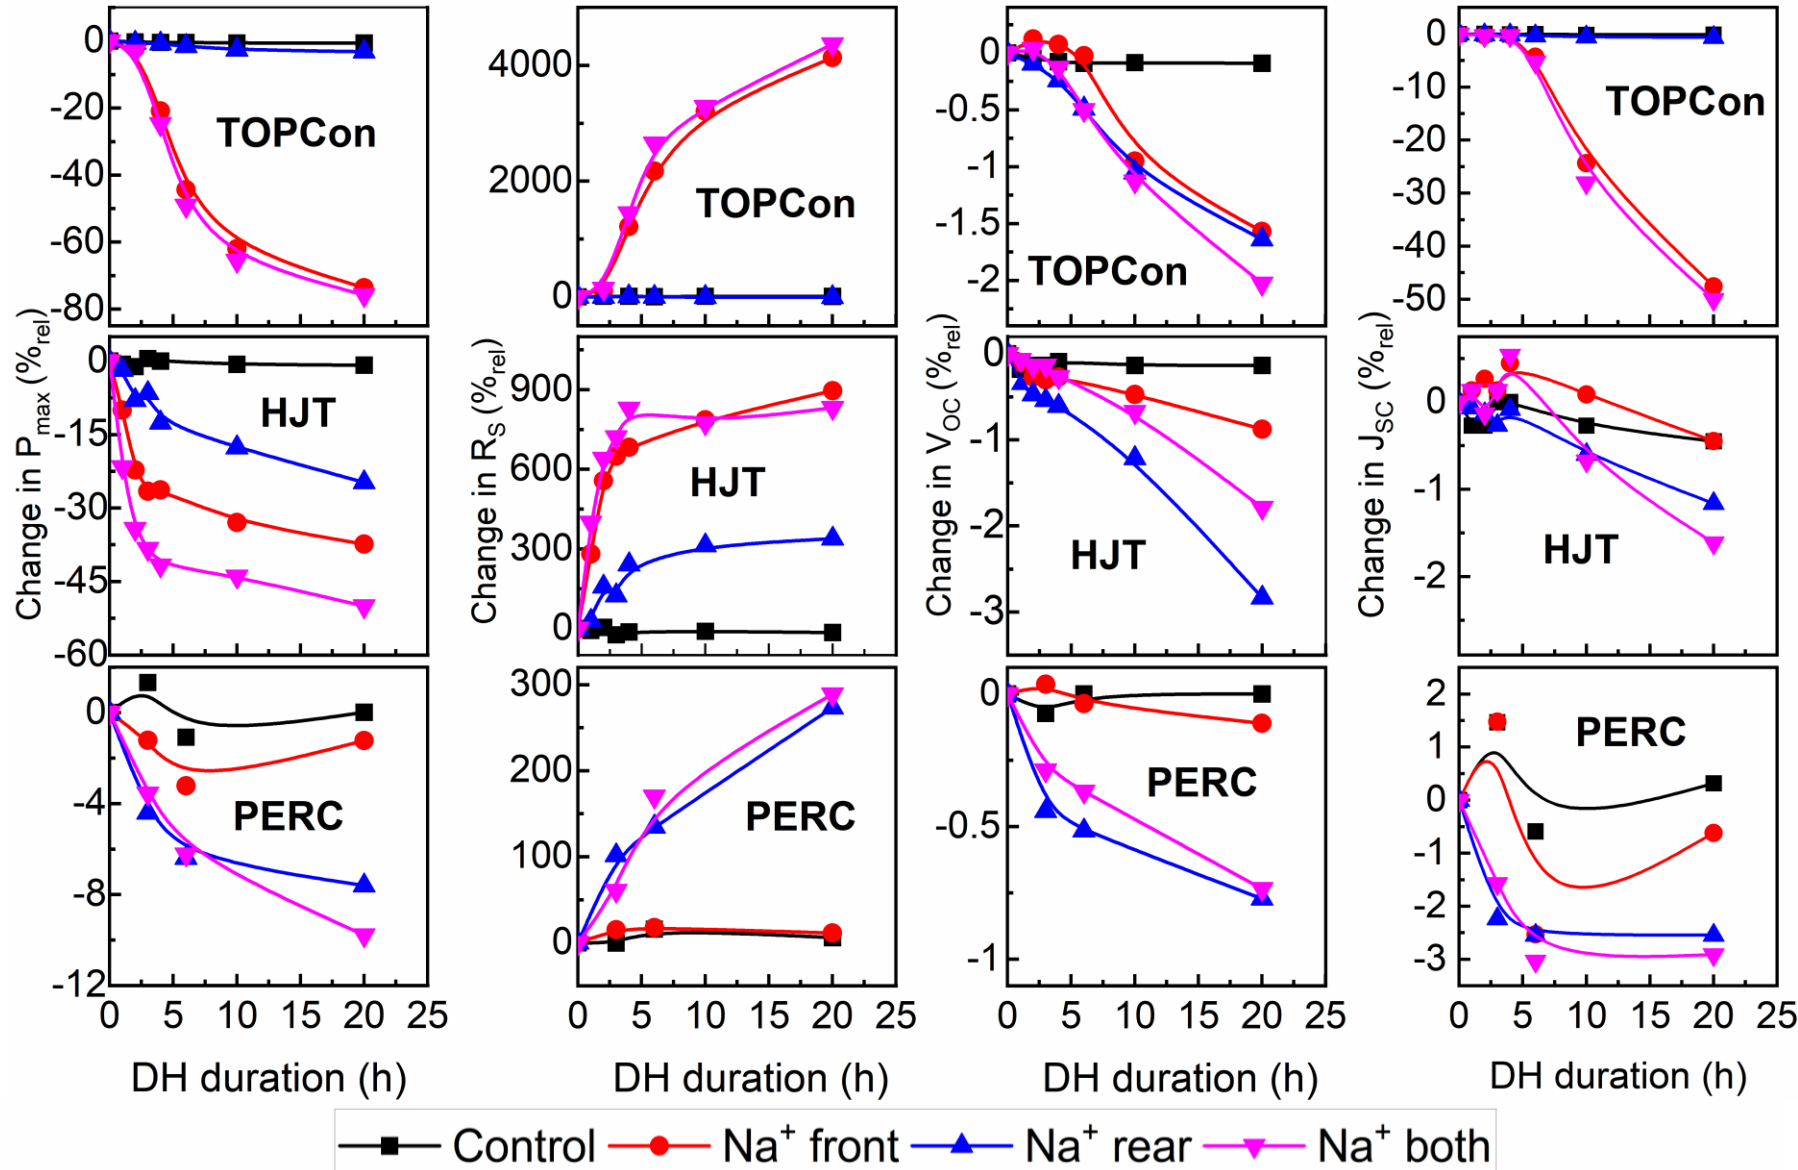
Change in I-V parameters after damp heat testing

- TOPCon cells degrade ~75%_{rel} (mainly on the front side).
 - HJT cells degrade ~50%_{rel} (both sides).
 - PERC cells degrade ~10%_{rel} (mainly on the rear side).
 - **Main loss is due to a severe increase in R_s .**
 - Slight recombination loss is also observed on both sides of TOPCon and the rear side of HJT and PERC solar cells.
 - V_{OC} and J_{SC} losses
- Note: a severe drop of J_{SC} (~50%_{rel}) in TOPCon is due to very bad R_s in these cells.

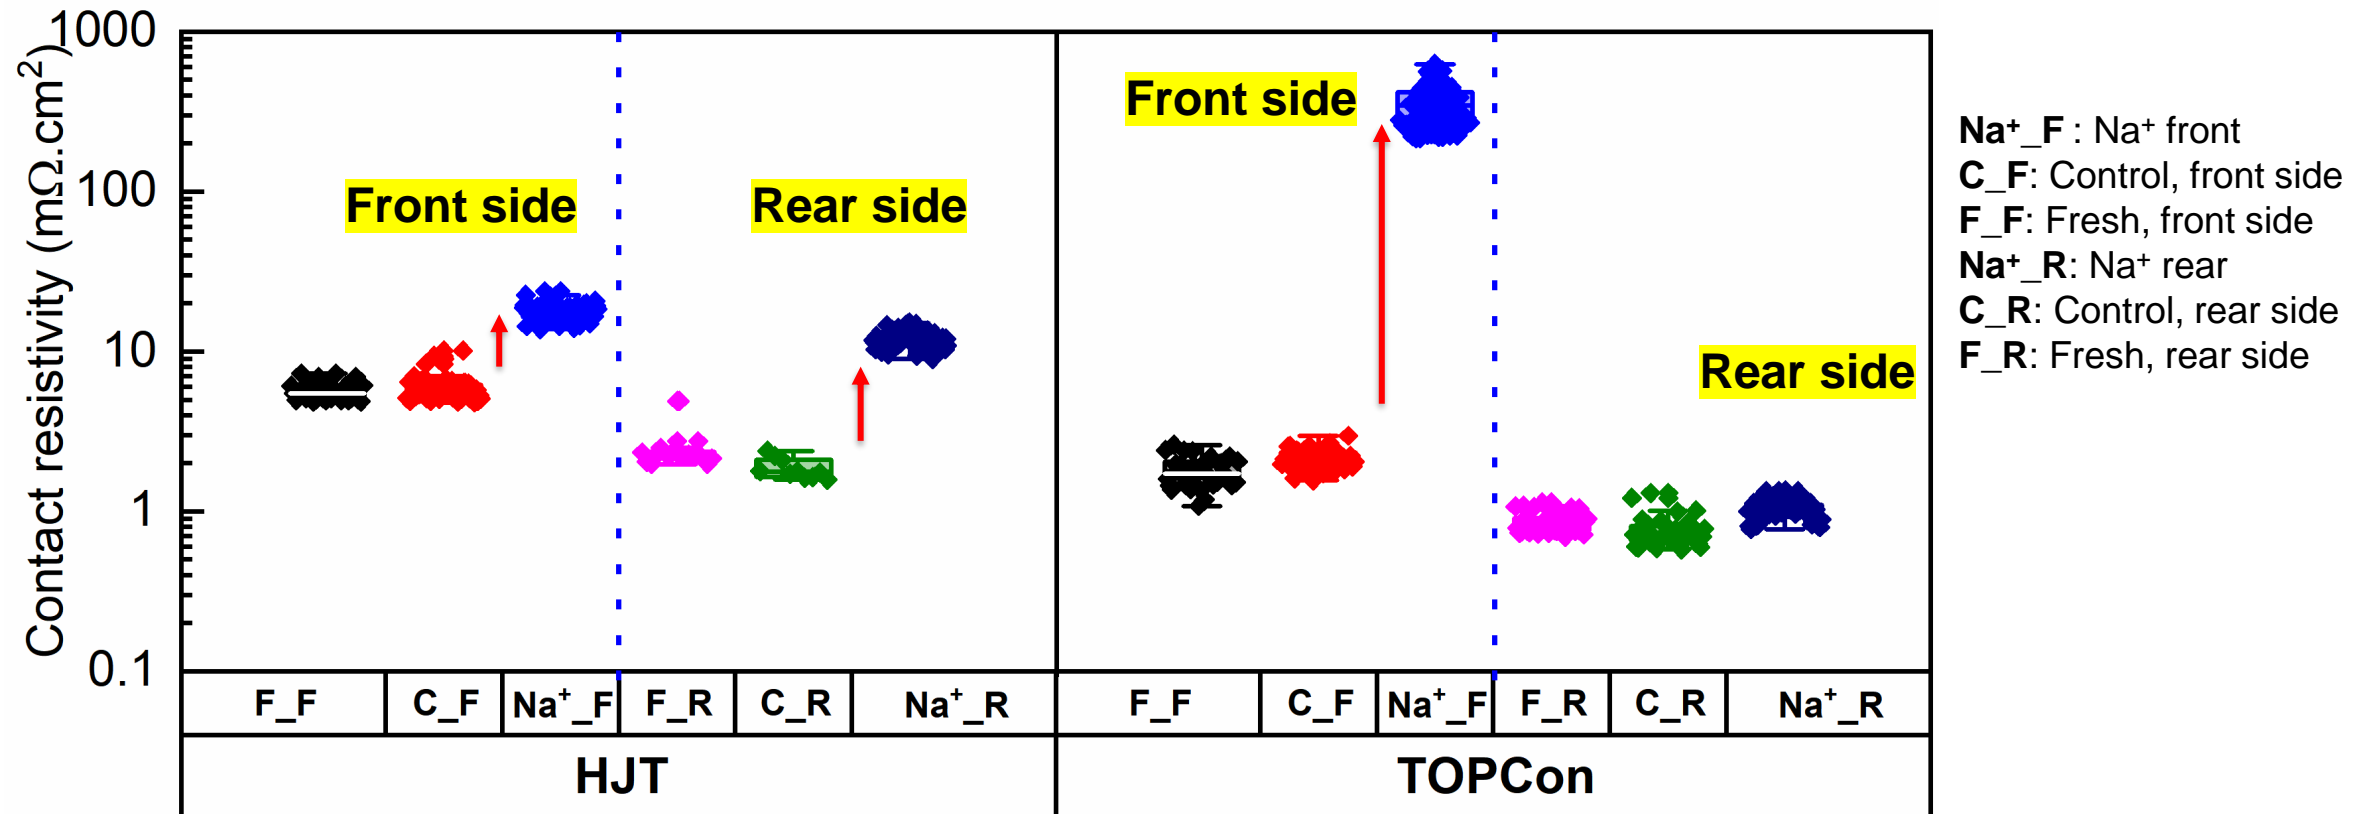
Increase in contact resistivity after damp heat testing

- No change in contact resistivity of the control cells (values are the same as the fresh cell that did not undergo DH testing).
- Contact resistivity of HJT cells with Na⁺ exposed only on the front or rear sides increased substantially after DH testing.
- Contact resistivity of TOPCon cells with Na⁺ exposed only on the front side significantly increased.

1. Contact resistivity on the rear side of the PERC cell was unable to measure as rear contact was completely compromised after 20h of DH testing.
2. No change in sheet resistance of all cells was observed after the DH test (data not shown here).

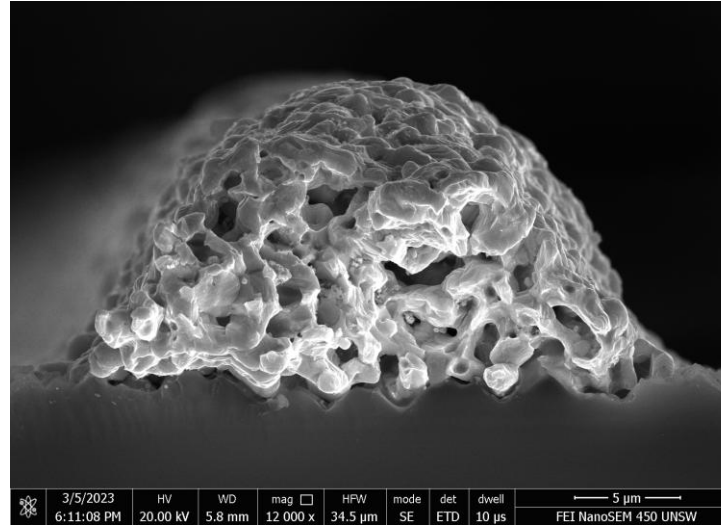
Na⁺ front

No significant change

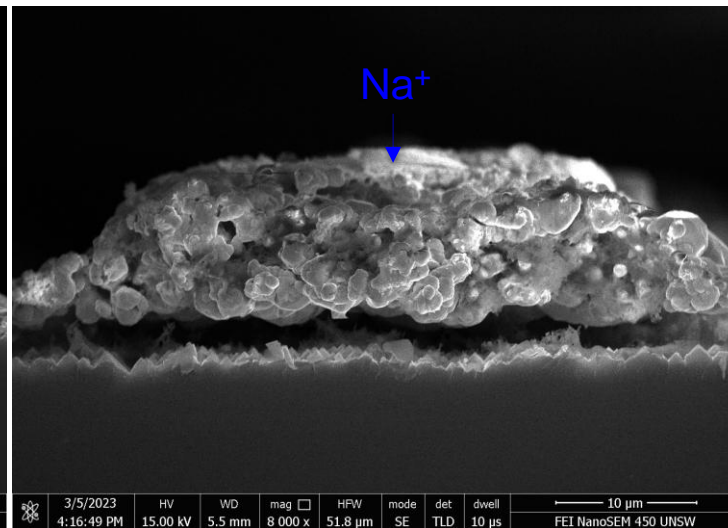
Na⁺ rear

→ Chemical reaction between Na⁺, moisture, Ag, and binder resin

→ Degradation of binder resin

→ Delamination of finger electrode and change in particle size (small to big) for both front and rear contacts

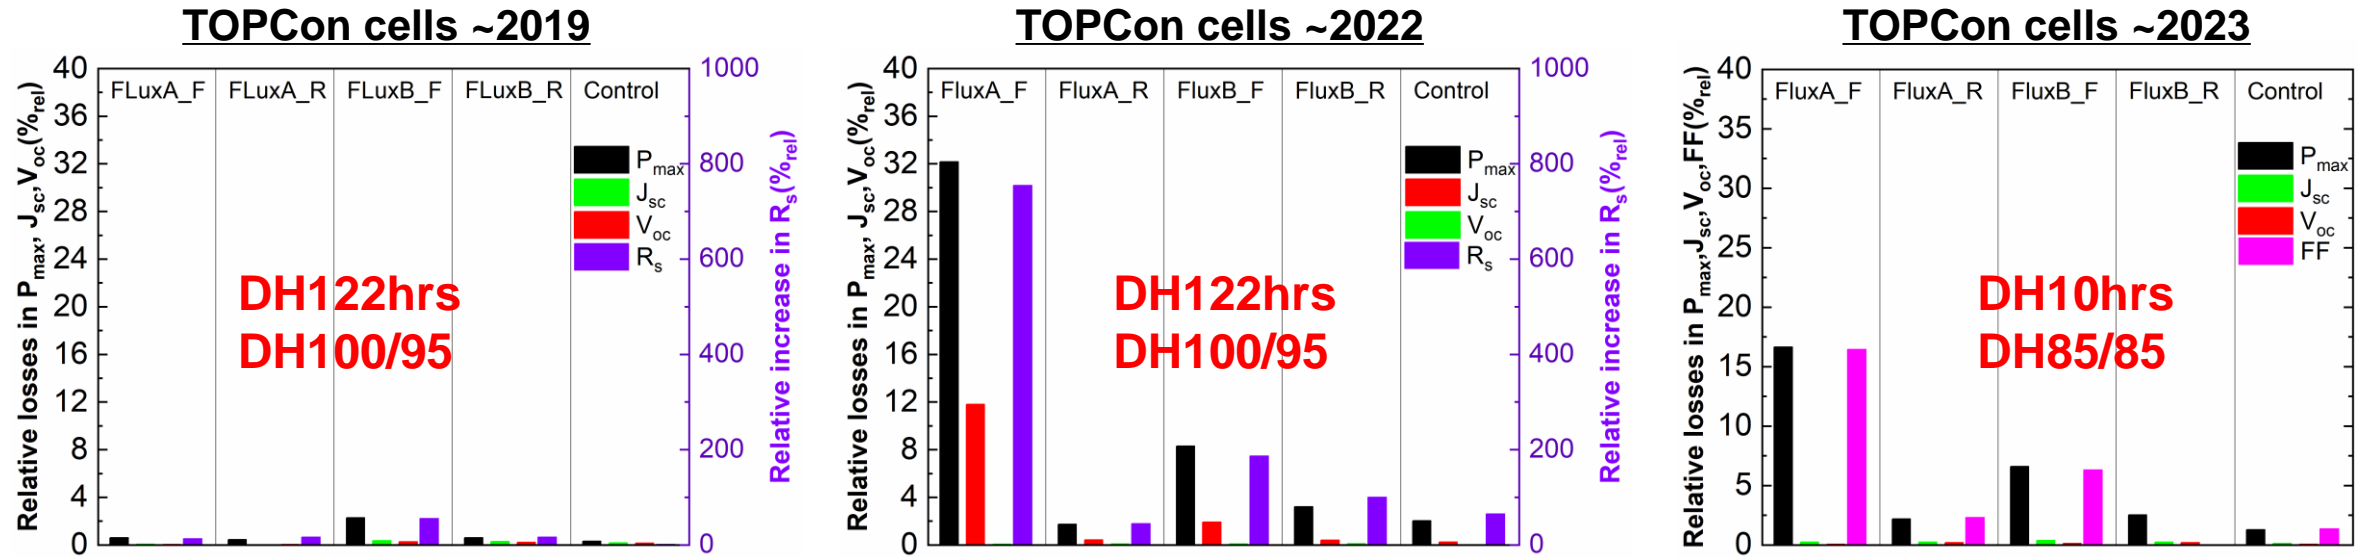
Changes in I-V results after damp heat (DH) testing

- TOPCon cells fabricated ~2019 remained stable after DH testing.
- However, cells fabricated ~2022 showed significant degradation after DH testing.
- TOPCon cells fabricated in ~2023 showed even higher degradation extent compared to those made in 2022.
 - Flux A had a more detrimental effect compared to Flux B.
 - Front side was more affected than the rear side.

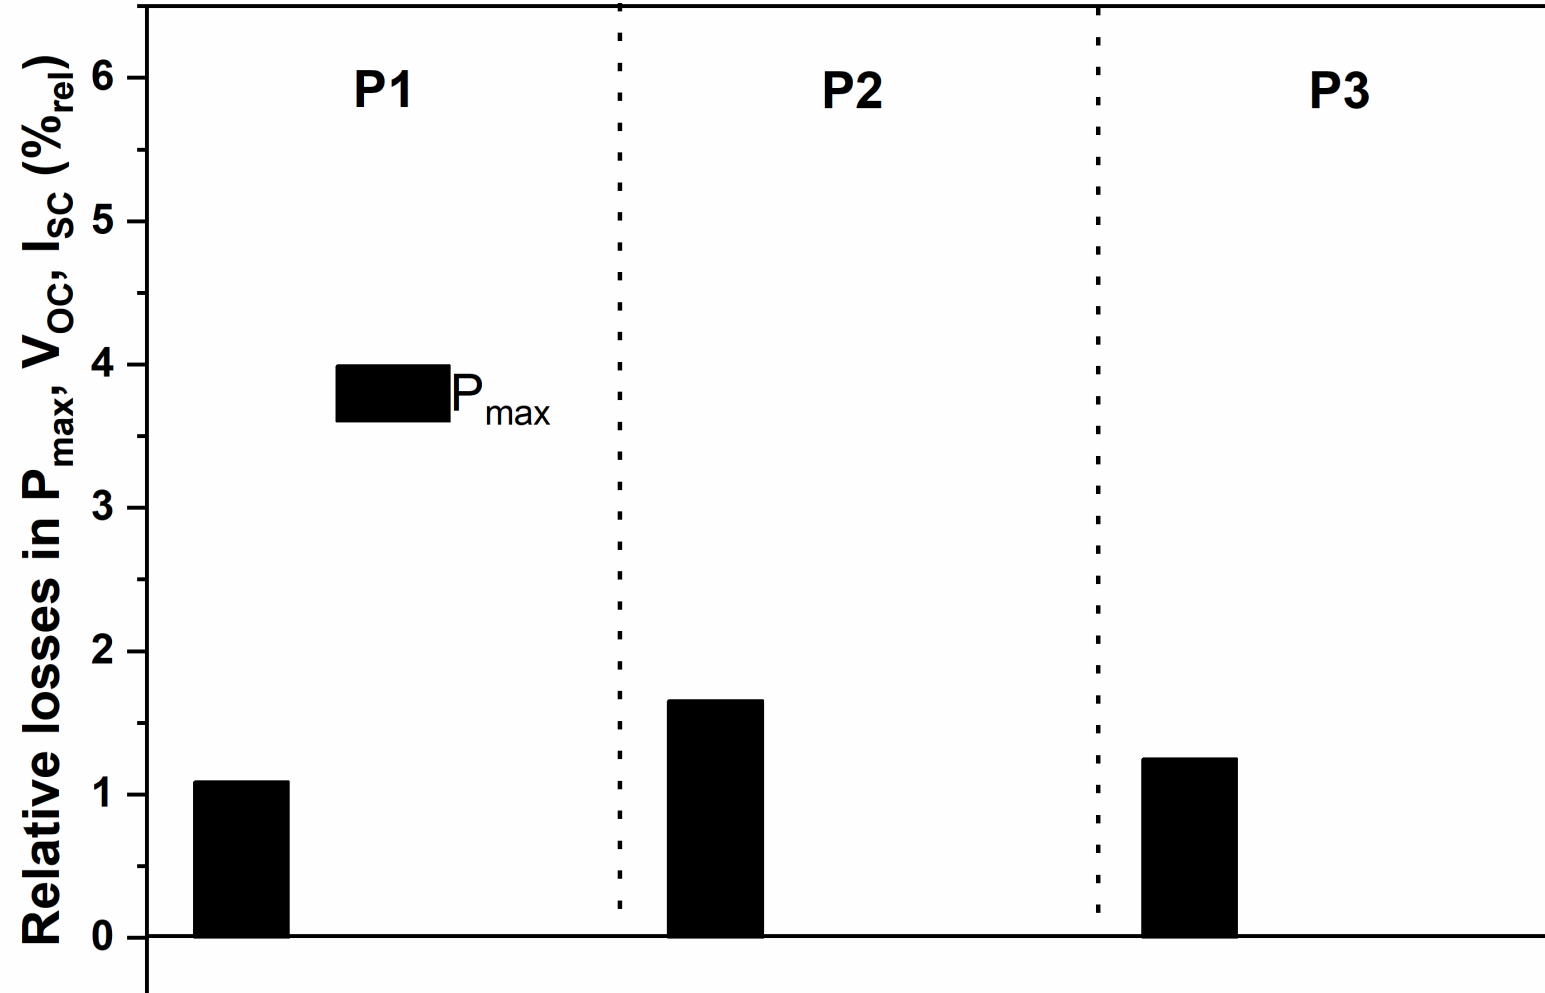
P3: p-G/POE-A/BS-W

→ All modules degrade less than 2%_{rel}.

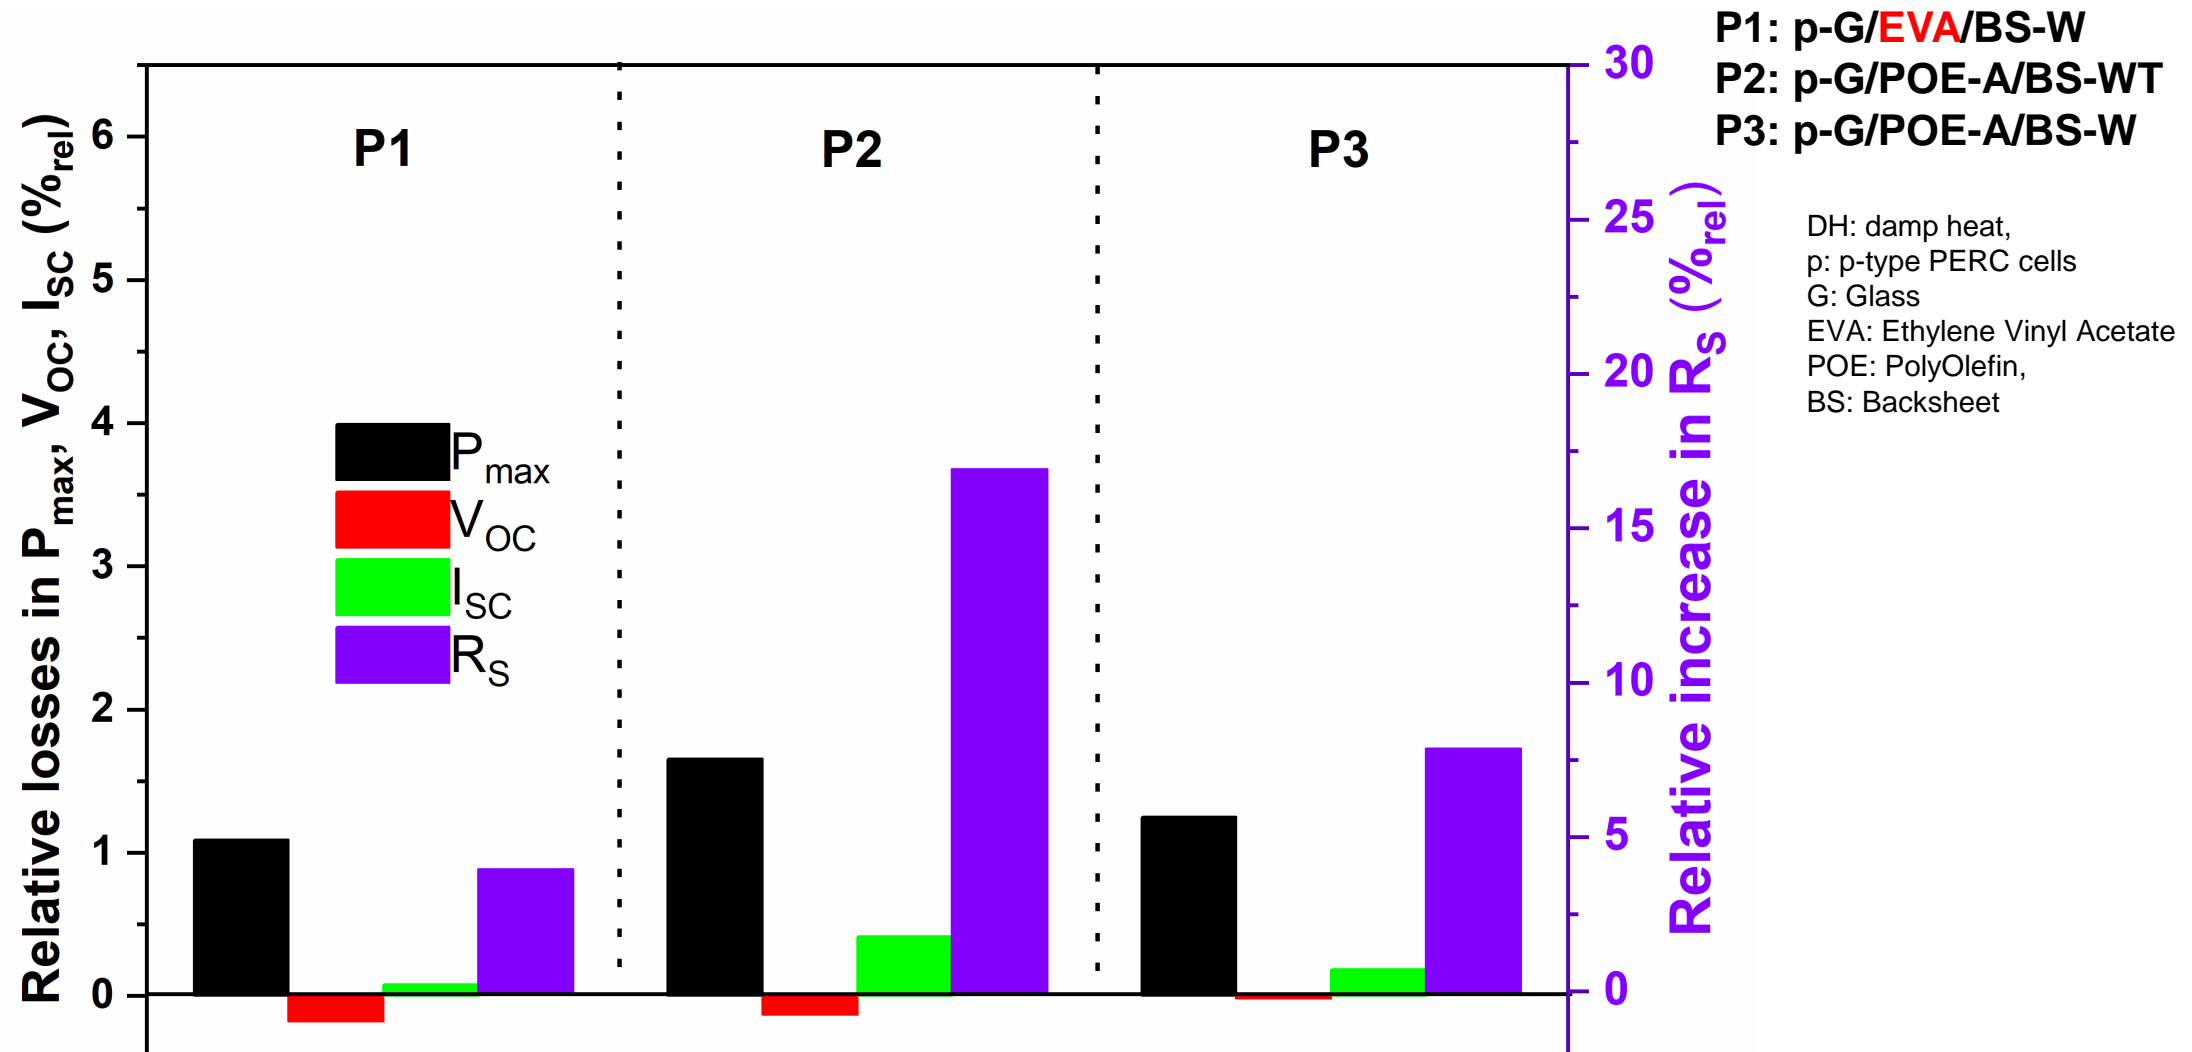
Changes in I-V parameters of modules with PERC cells after DH1000hrs

- All modules degrade less than 2%_{rel}.
- Loss mainly driven by the R_s increase.

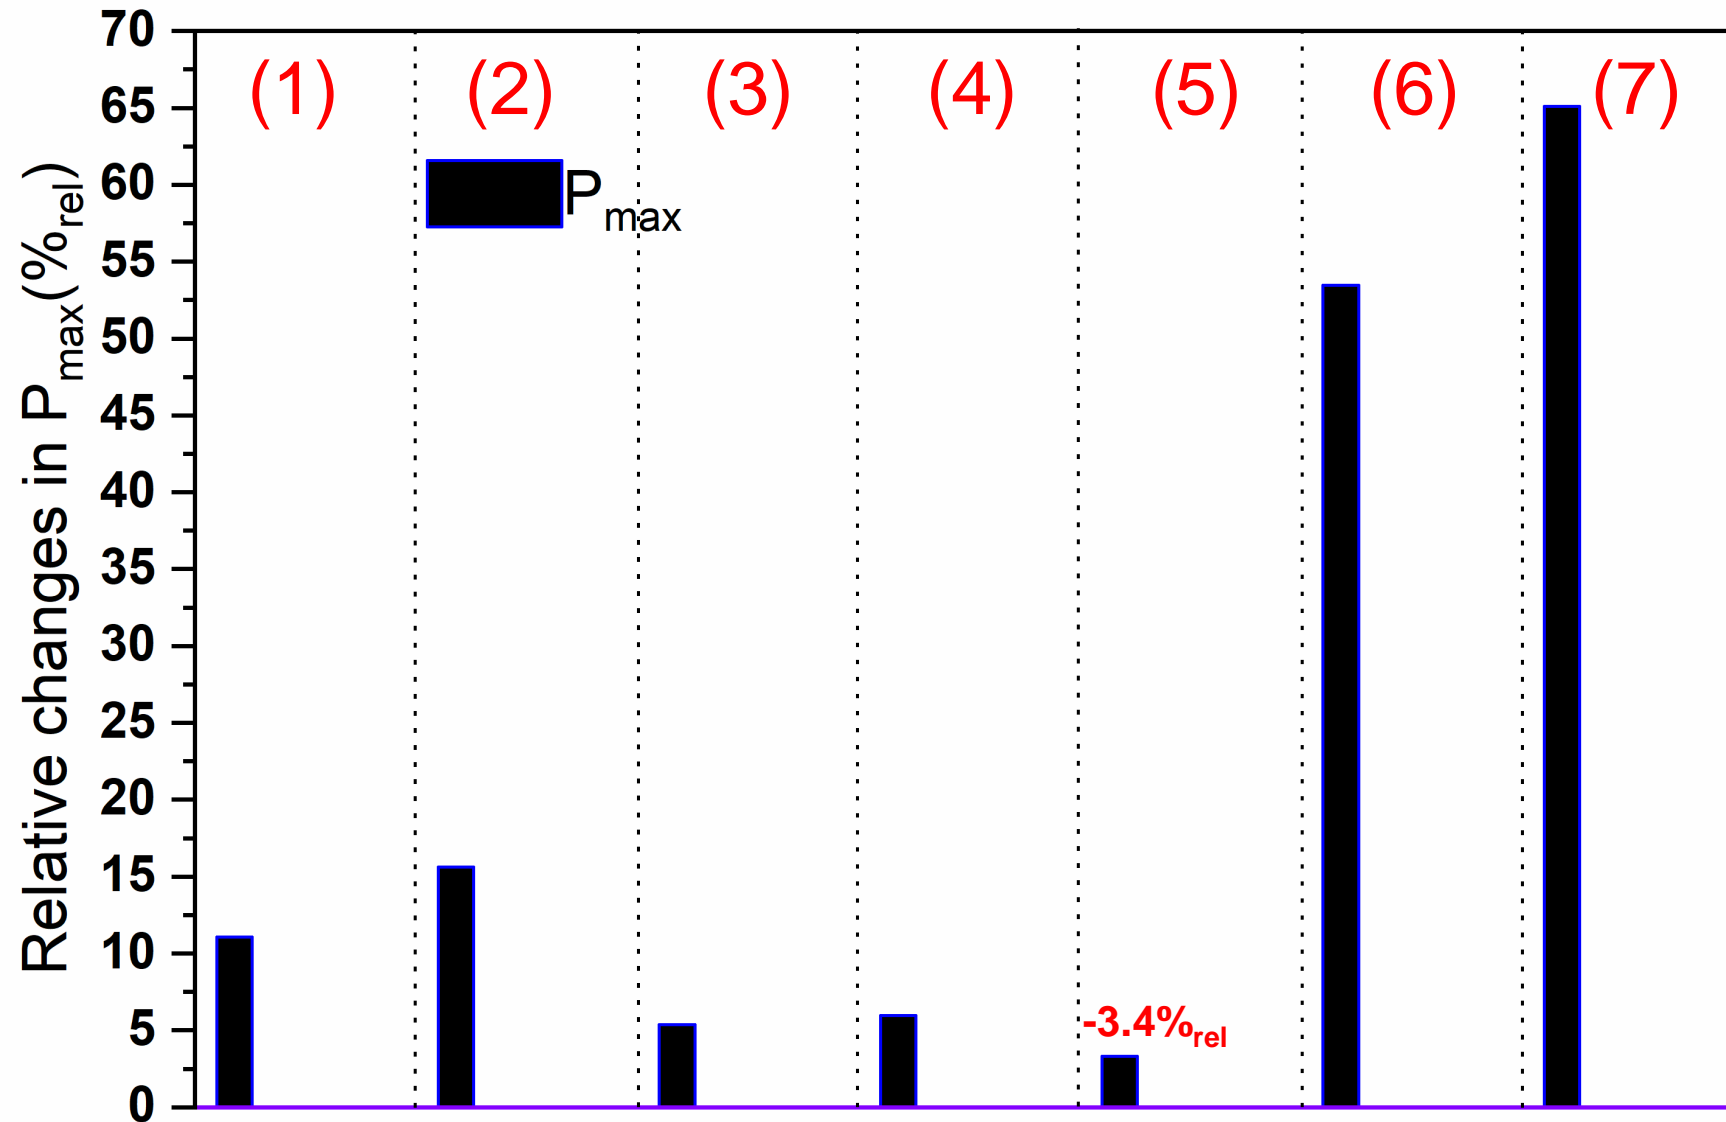
Changes in I-V parameters of modules with TOPCon cells after DH1000hrs

→ Degradation extent is beyond the minimum loss specified in the IEC standard ($\leq 2\%$ relative after DH2000hrs).

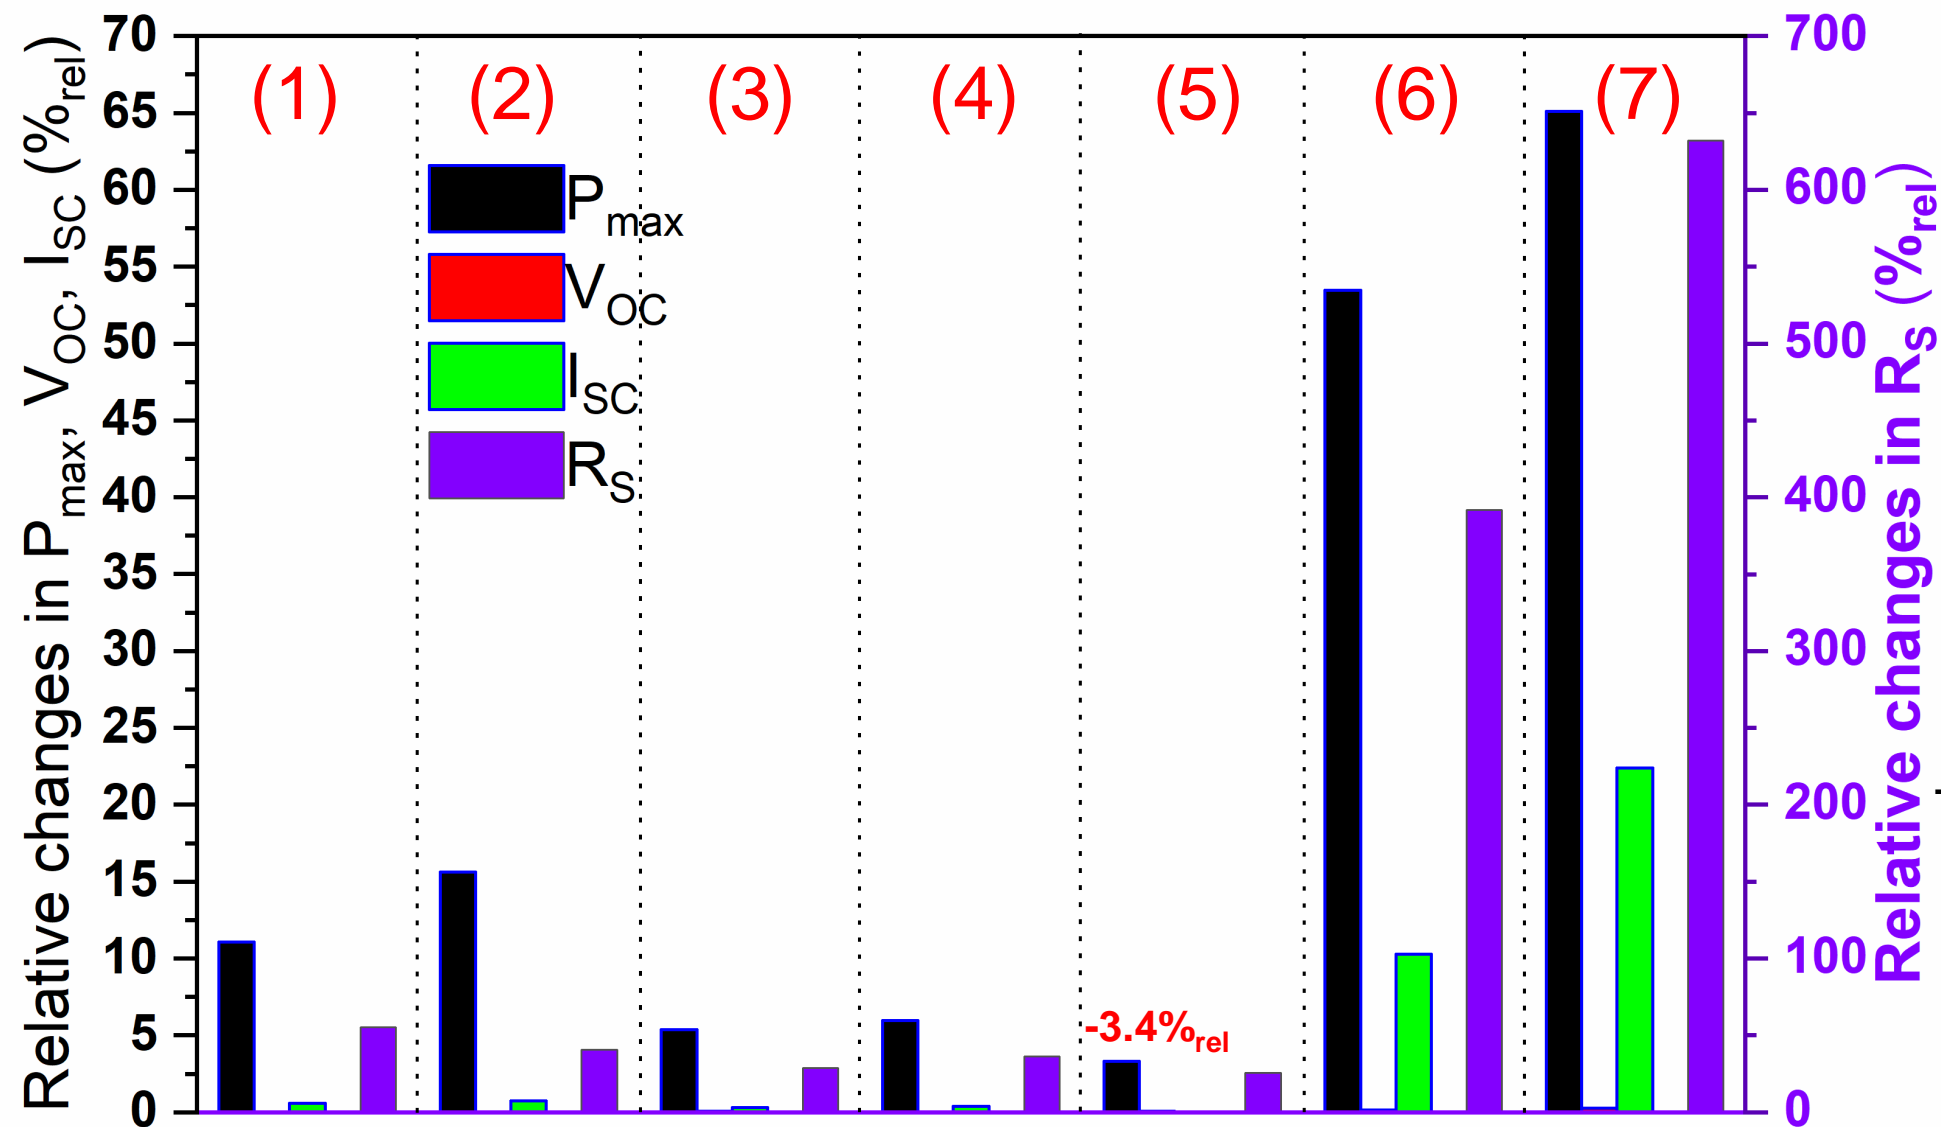
Changes in I-V parameters of modules with TOPCon cells after DH1000hrs

→ Degradation extent is beyond the minimum loss specified in the IEC standard ($\leq 2\%$ relative after DH2000hrs).

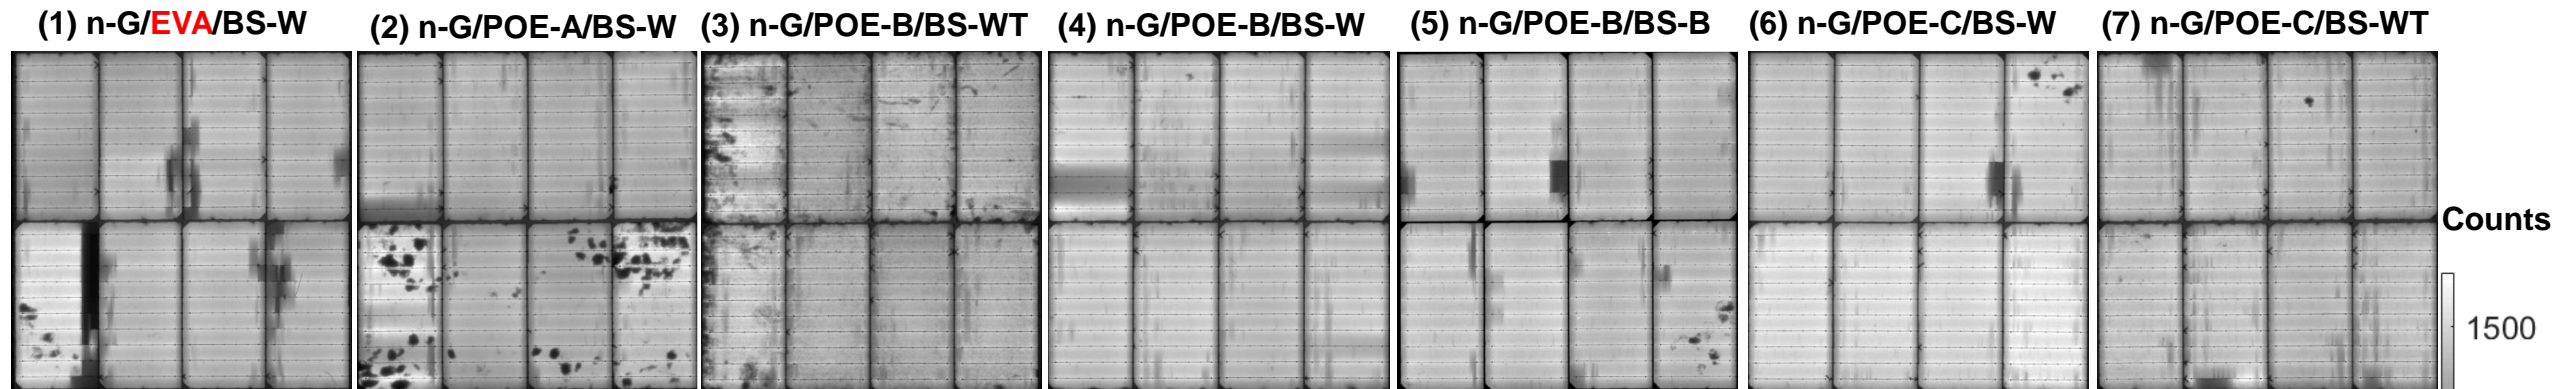
Changes in EL images of modules with **TOPCon cells** after DH1000hrs

- Degradation extent is beyond the minimum loss specified in the IEC standard ($\leq 2\%$ relative after DH2000hrs).
- Failure modes are random
- Modules with EVA degrade less than some modules with POE-C, indicating failure isn't solely related to acetic acid.....

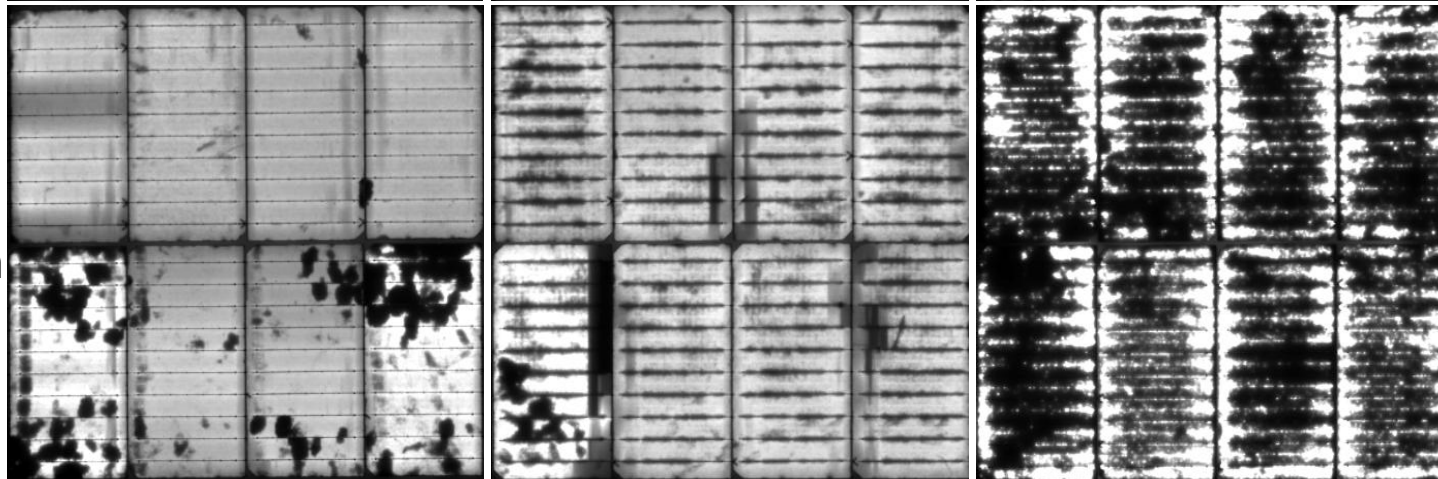
DH1000h

P_{\max} loss ~15%_{rel}

P_{\max} loss ~11%_{rel}

Type-1 failure mode: point-localized failure

Type-2 failure mode: failure at/around the interconnection point

Type-3 failure mode: failure across the entire area of cells/module

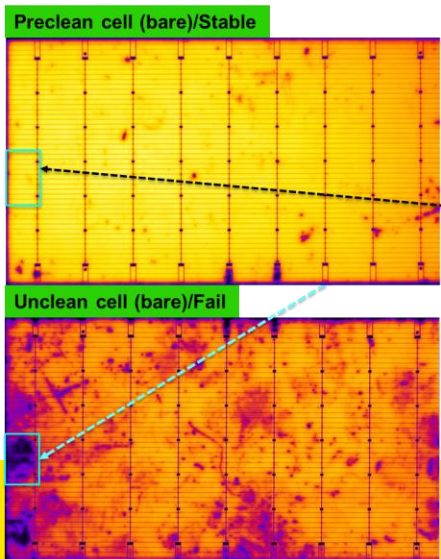
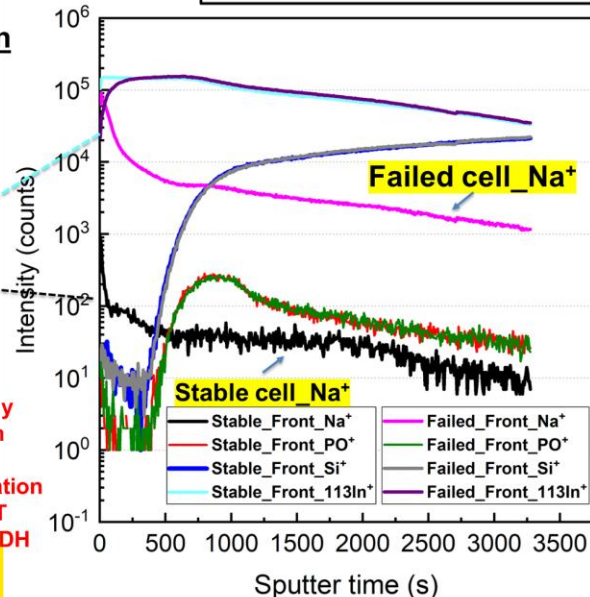
P_{max} loss ~15%_{rel}
 I_{sc} loss ~0.8%_{rel}
 R_s increase ~55%_{rel}

Higher Na⁺ ion detect on failed region

→ Na⁺ is likely involved in causing recombination loss in HJT cells after DH testing

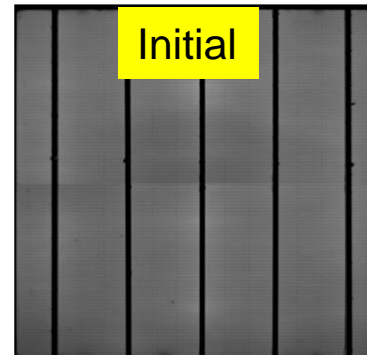
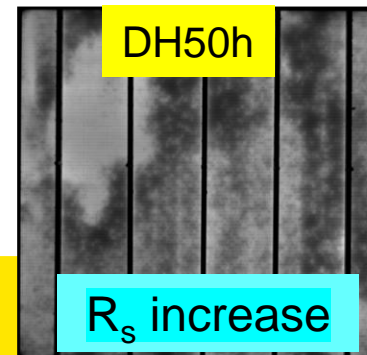
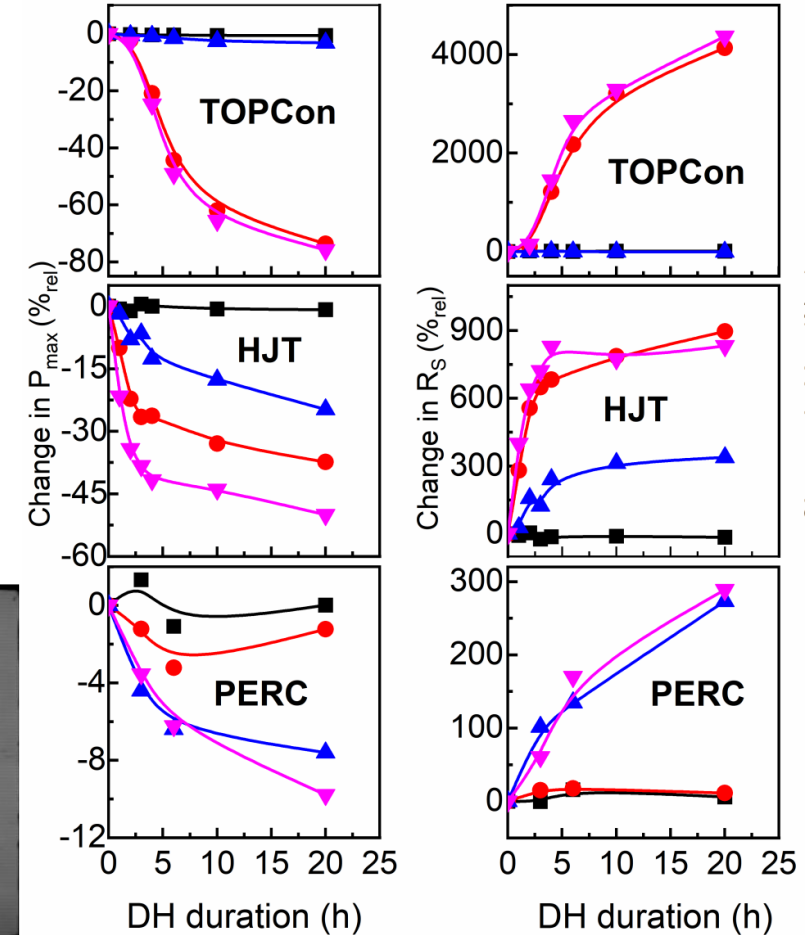
Soldering flux B_{front}

R_s increase
