From the Lab to the Field: Decoding Degradation at Cell, Module, and Field Level for SHJ and TOPCon

SPREE Seminar, 4 April 2025, Sydney, Australia

Bram Hoex, Chandany Sen, Muhammad Umair Khan, Xinyuan Wu, Xutao Wang, Haoran Wang, Jiexi Fu, Shukla Poddar, Phillip Hamer

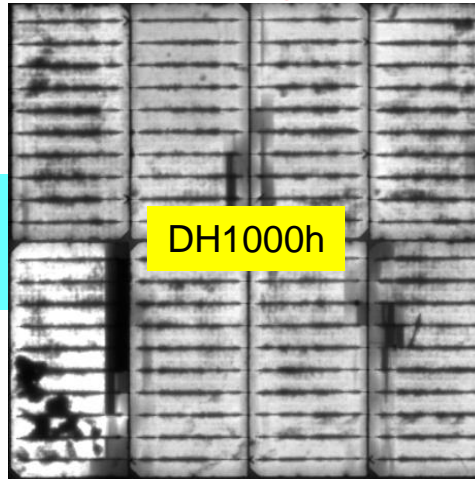
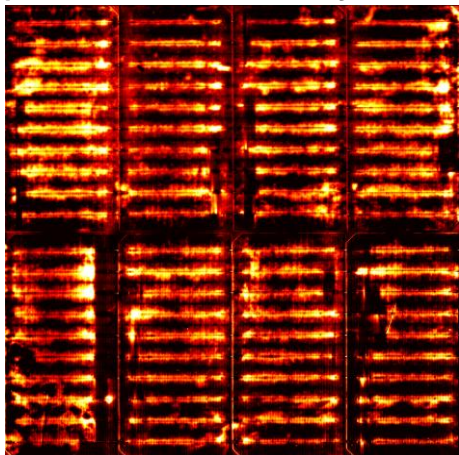
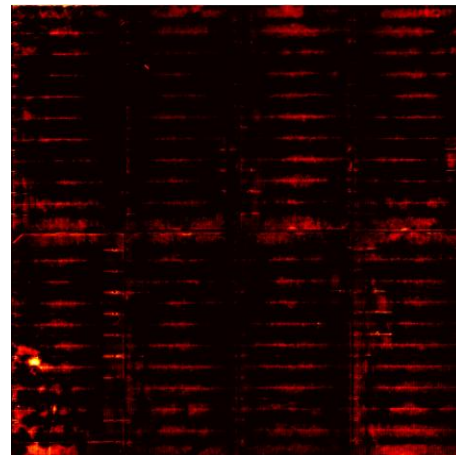
EL images

Type-2 failure mode: potential root causes: Soldering flux with/o acetic acid

Region with R_s increases

Region with recombination increases

P_{max} loss ~11%_{rel}
I_{SC} loss ~0.8%_{rel}
R_s increases ~50%_{rel}

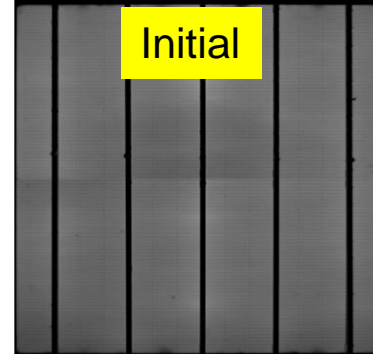
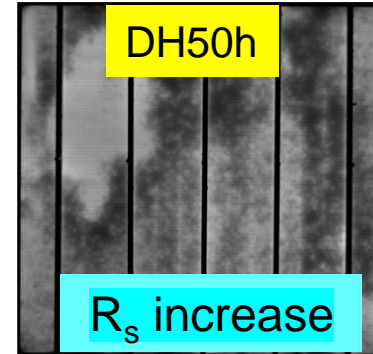
Soldering flux B_front

R_s increase

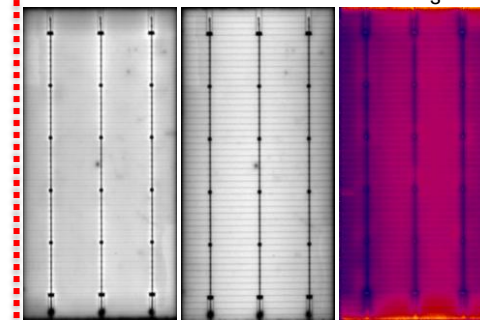
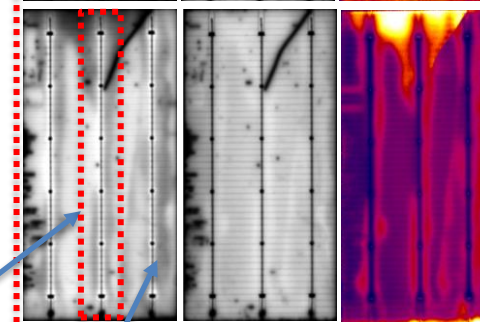
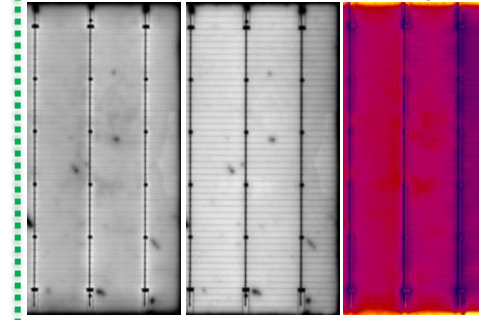
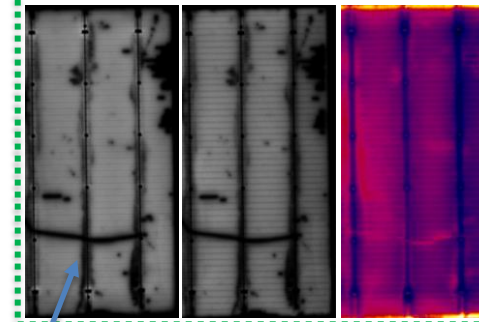
Region soldering flux applied

Soldering flux
R_s increase

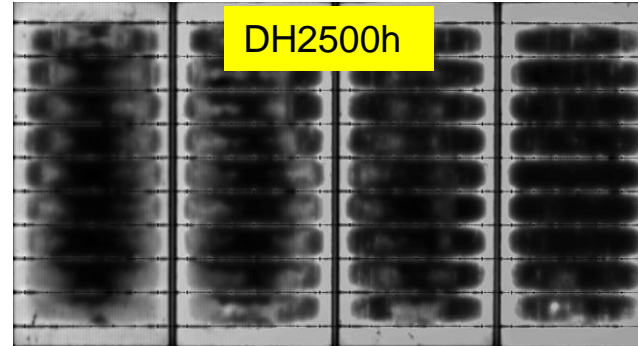
Type-3 failure mode
(HJT modules)

Type-3 failure mode in TOPCon: potential root causes: **Soldering flux and POE**

- Type-3 failure mode in TOPCon module with POE occurs more quickly than that of the HJT module with EVA.
 - Therefore, it is speculated that some **additive release from POE** is also involved in causing Type-3 failure mode in TOPCon modules.

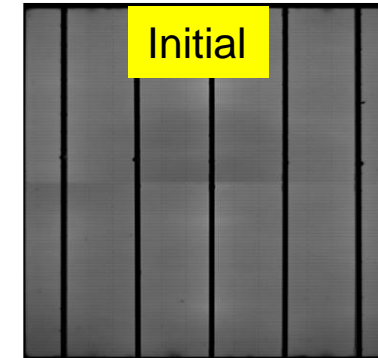
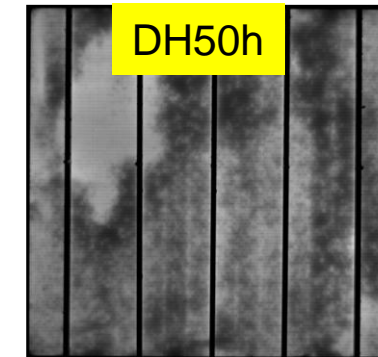
TOPCon cell

Soldering flux,
metal finger

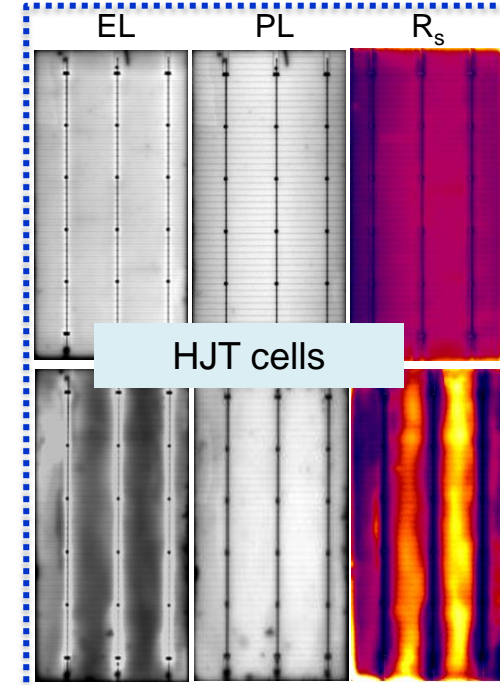
Type-3- HJT cell

Soldering flux, metal
finger, ITO layer

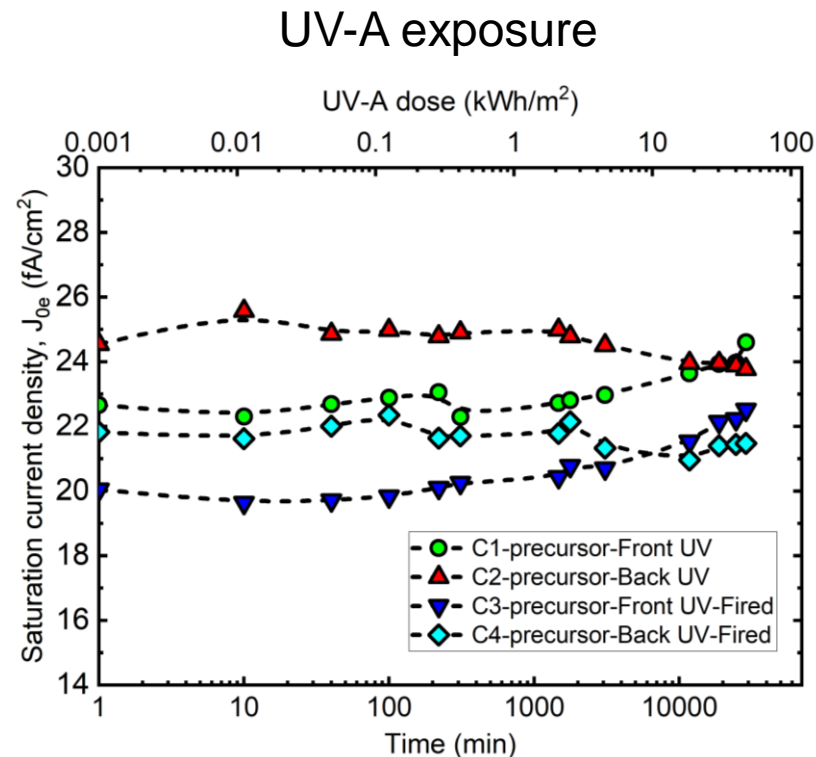
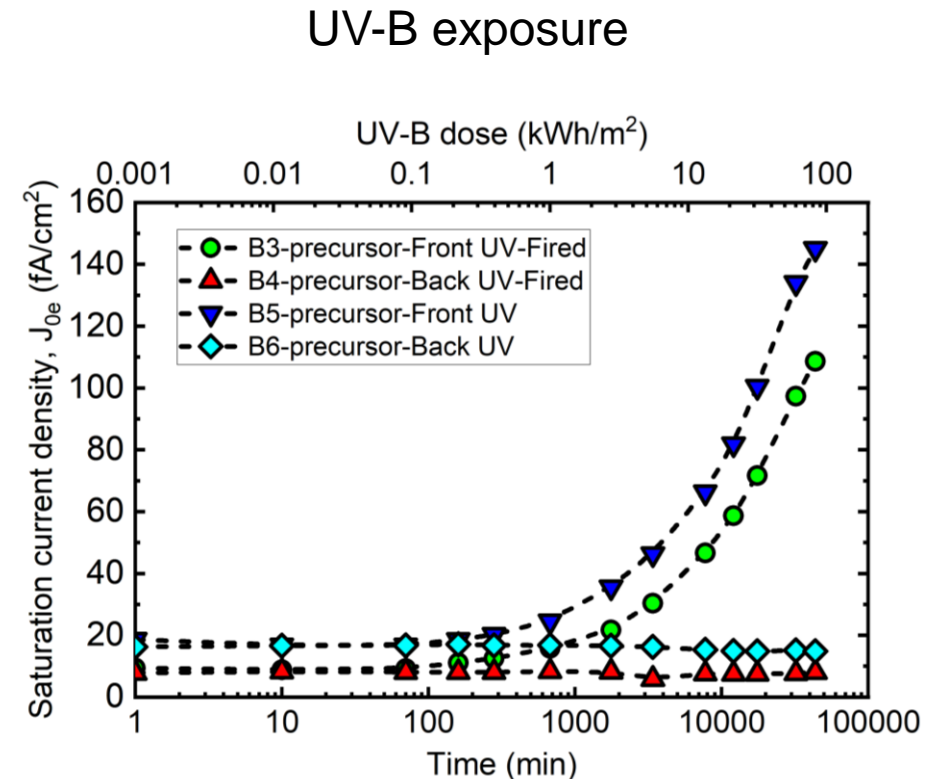
UVID in TOPCon solar cells

- Tested TOPCon solar cells are susceptible to UVID on the front but not at the rear.
- Accelerating UVID testing is crucial for obtaining quick feedback in a fast-paced industry.
- Our research revealed that UV-B wavelengths significantly accelerate degradation compared to UV-A wavelengths without introducing new failure modes.

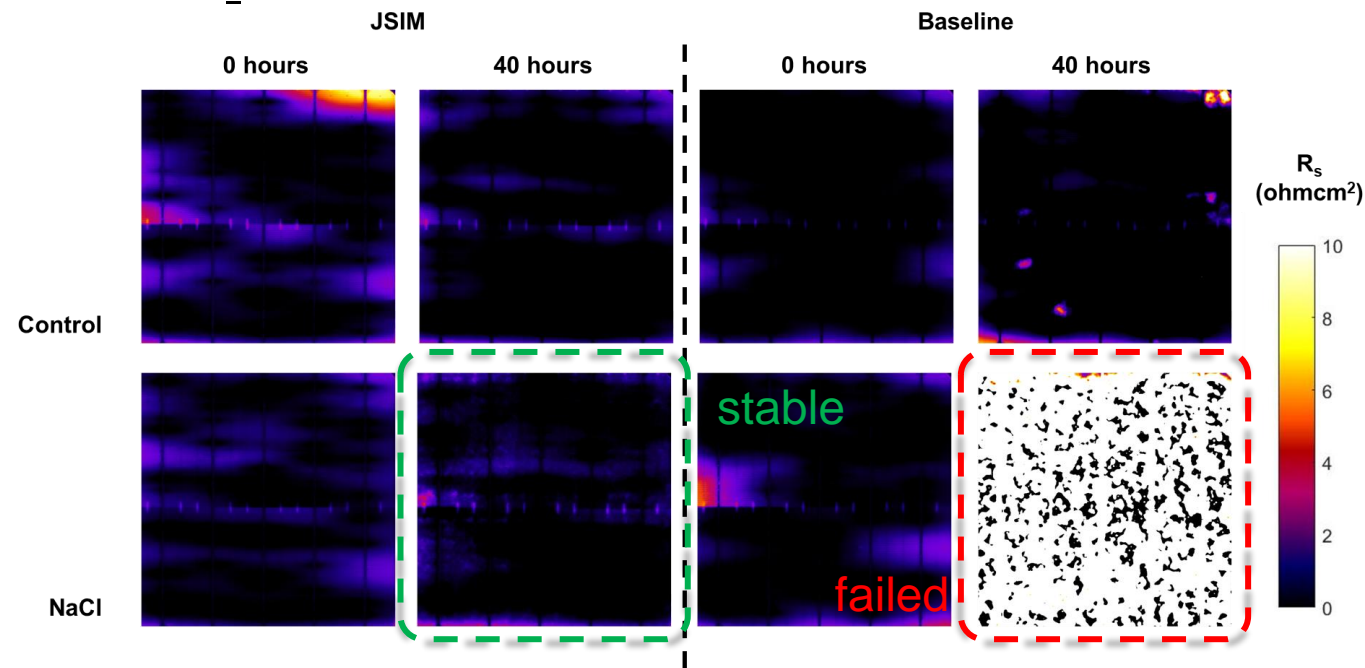
➤ R_s mapping with DH85

Enhancing DH Stability Through Metallization Optimization

➤ Laser-assisted firing process developed by Jolywood

Jolywood Special Injected Metallization (JSIM)

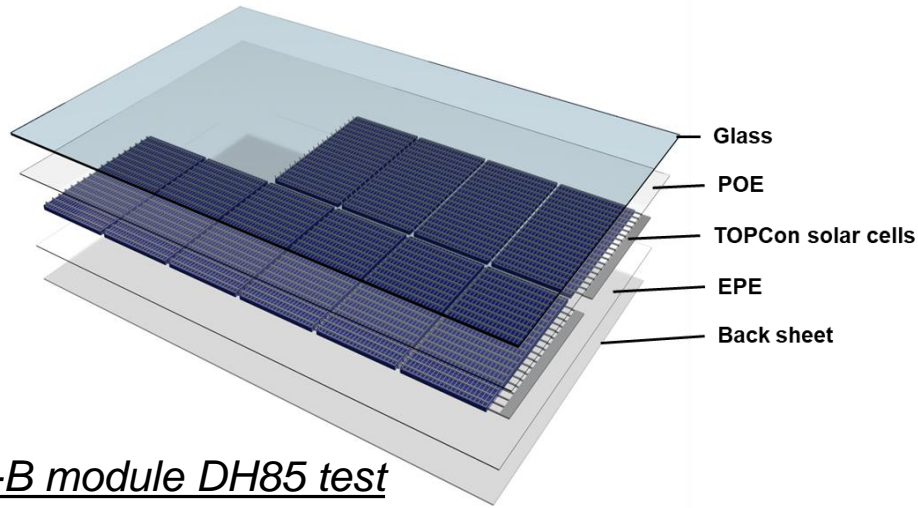
➤ Electroluminescence images

Assessing Module-Level Stability of JSIM

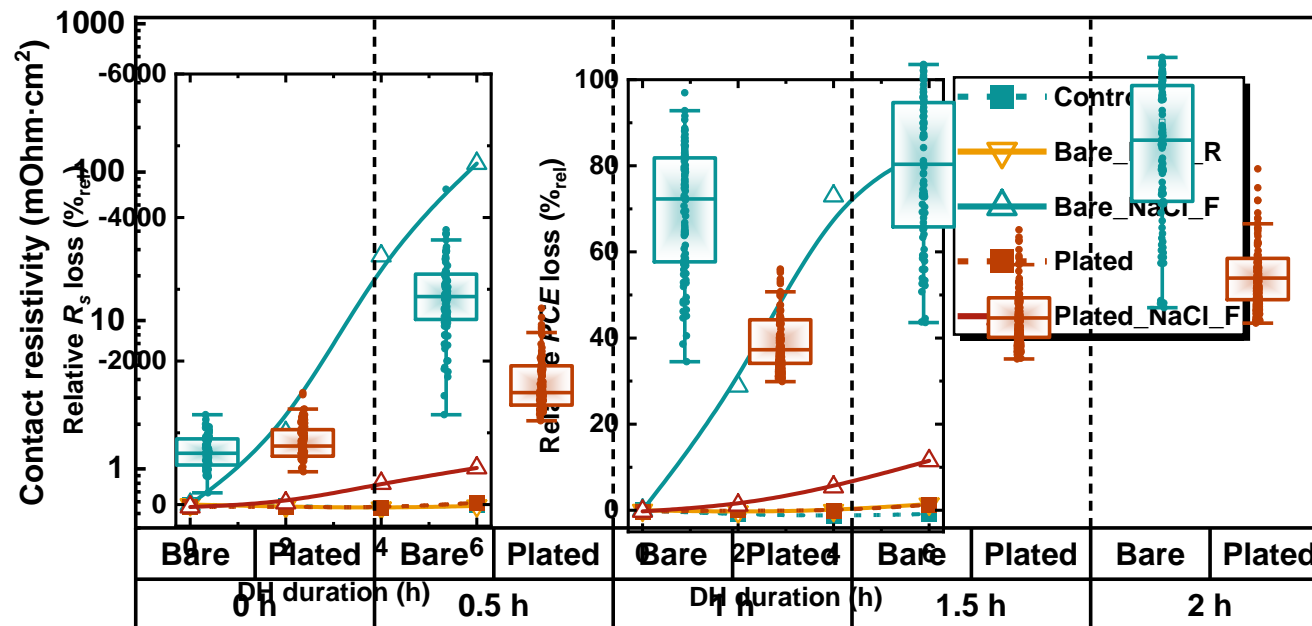
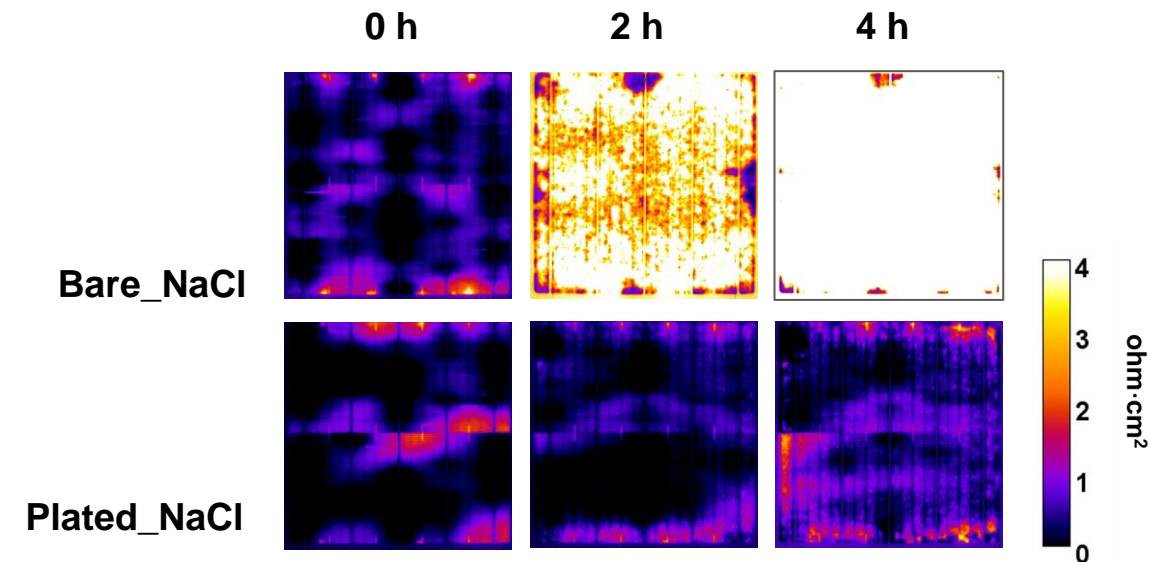
Enhanced stability with plated-Cu

Mitigating contaminant-induced damp-heat degradation via copper plating

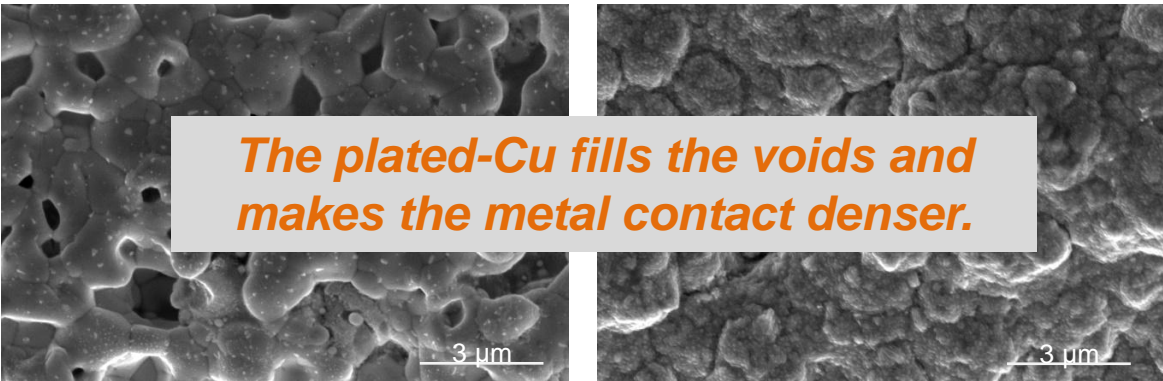
Top-view SEM

Protection mechanism of plated-Cu

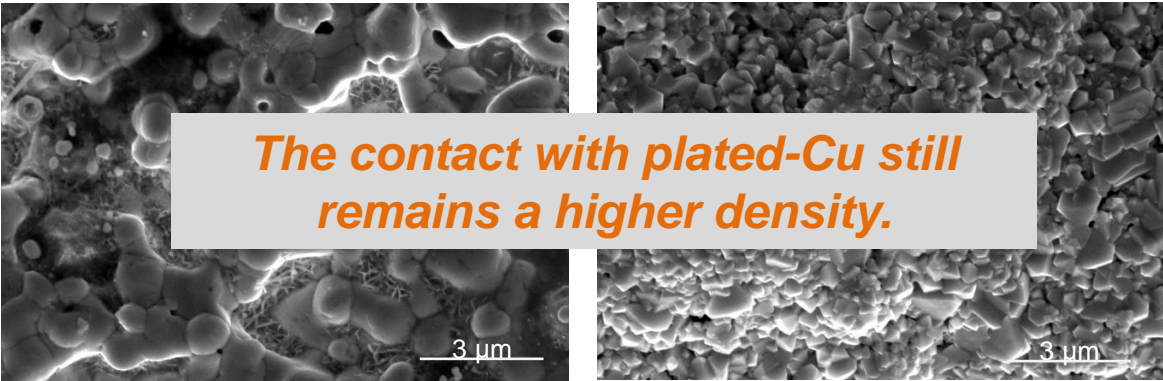
Bare_NaCl

Plated_NaCl

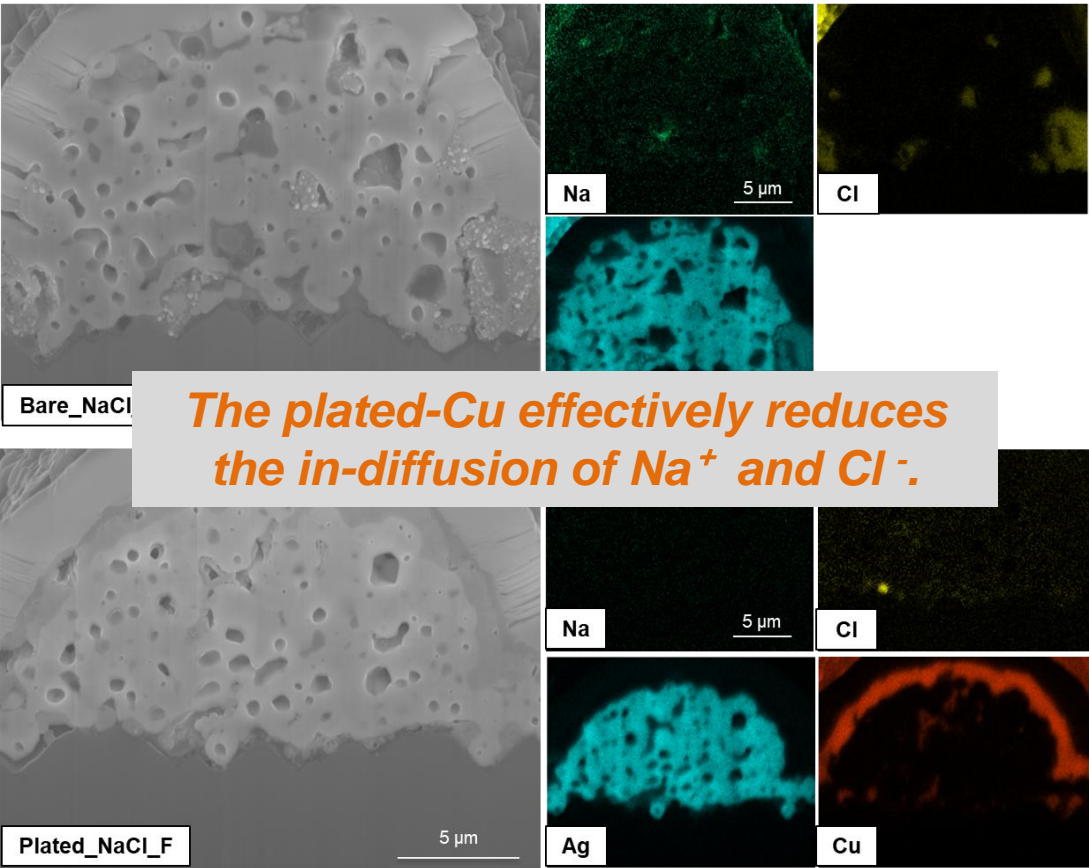
Cross-sectional SEM

Atomic ratio (%)	Na/Ag	Cl/Ag
Bare_NaCl	1.36	2.33
Plated_NaCl	0.00	0.22

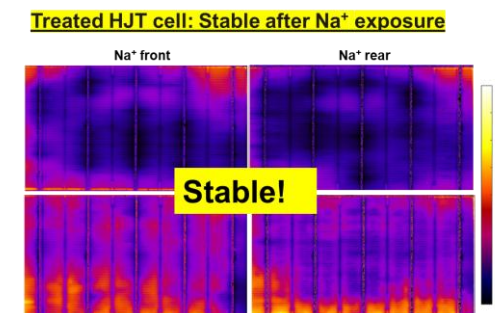
- Several failure modes in the HJT glass-backsheet full modules were detected with losses up to 22.5%_{rel}
- The root causes of each failure mode were unclear
- These failure modes occurred randomly in the full-modules
- Some of these failure modes were not observed in PERC modules previously
- Limited/no reports on failure modes in HJT glass-backsheet modules
- Cell-level testing developed for PERC cells (IEC 61215-2:2016) is unable to detect these failure modes

EL images of HJT full modules before and after 1000 h of DH testing
